Final Report
Version 2
September 2012

Evaluation of Diesel Particulate Filter Systems at Stobie Mine

Diesel Emissions Evaluation Program

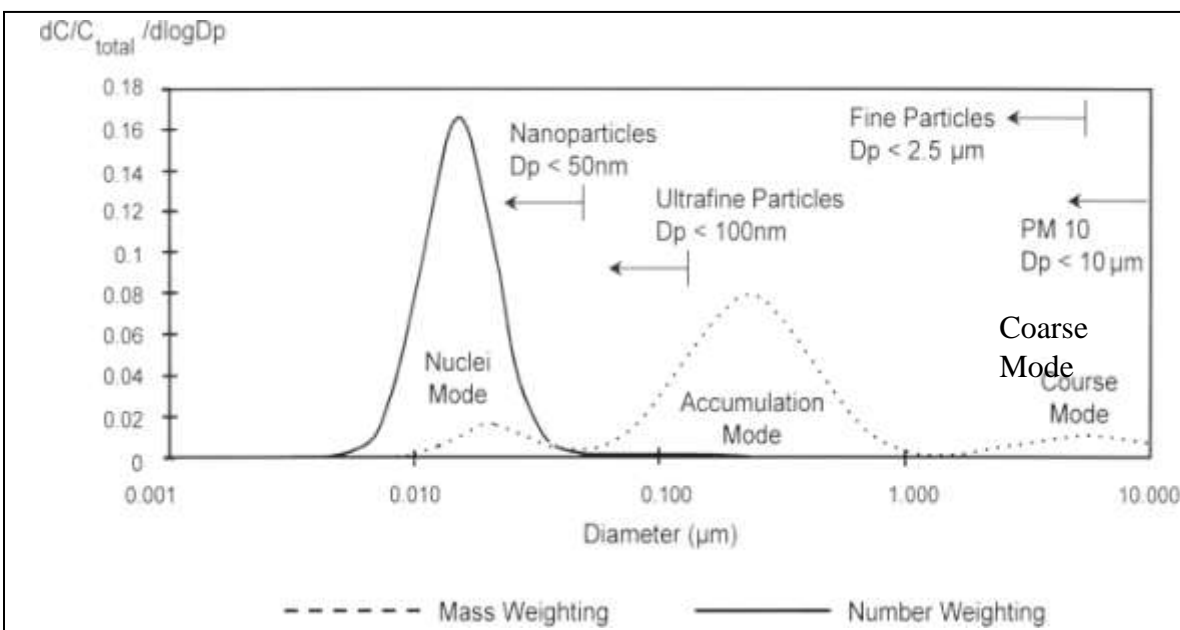
Figure 3: Typical particle size distribution of DPM (after Kittelson, 1998)

A schematic of the components of diesel exhaust is shown in Figure 1, their typical proportions are shown in a pie chart in Figure 2. A typical particle size distribution summed over the operating modes of a diesel engine is shown in Figure 3.

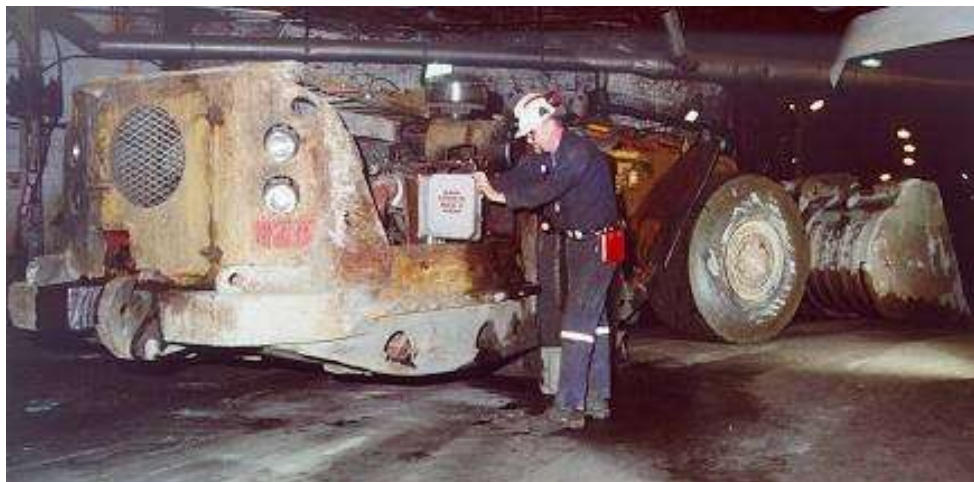
Figure 7: Vehicle #820, Wagner ST8B scooptram with Deutz F12L-413FW engine.

LHD #820: Atlas Copco Wagner Scooptram™ ST8B, shown in Figure 7 with specifications shown in Table 2.

Vehicle service:	heavy-duty, LHD
Engine:	Deutz F12L-413FW
Engine displacement:	19.14 L
Engine Type:	12 cylinders, V configuration, 4 stroke, mechanically controlled, turbocharged
Rated Power:	280 HP @ 2300 rpm
Transmission:	Automatic

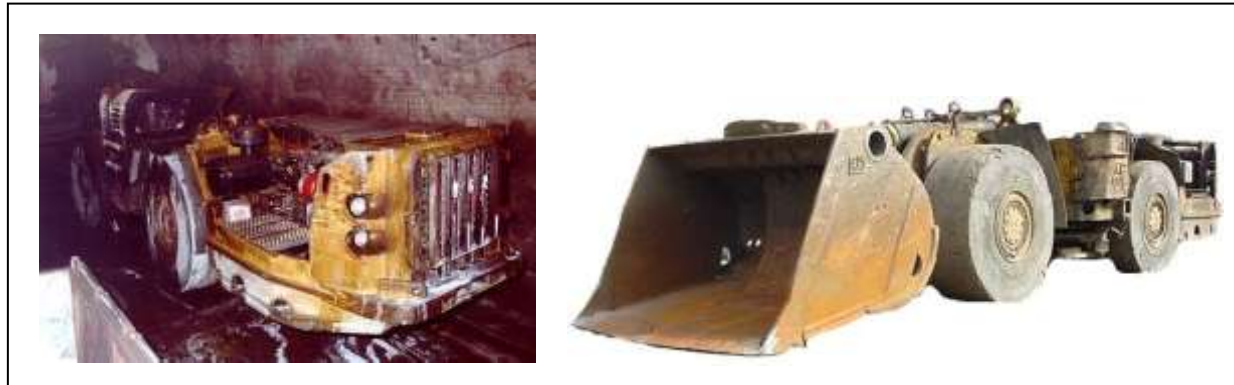
Figure 8: Vehicle #362 (left) and #445 (right) - Wagner Scooptrams with DDEC 60 engines.

LHDs #362 and #445: Atlas Copco Wagner ST8B Scooptrams, shown in Figure 8 with specifications given in Table 3.

Vehicle service:	Heavy duty, LHD
Engine:	DDEC Series 60
Engine displacement:	11.1 L
Engine Type:	6 cylinders, in-line, turbocharged
Rated Power:	325 HP @ 2100 rpm (engines are derated to 285 HP)
Transmission:	Automatic

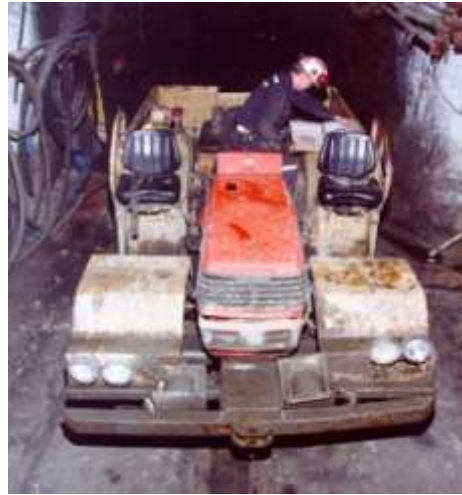
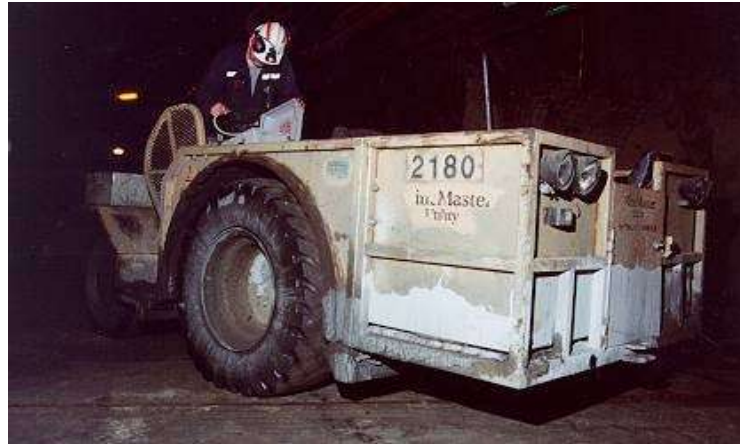
Figure 9: Vehicles #621 (left) and #2180 (right) - Kubota tractors

Tractors # 621 and #2180: Kubota Tractors (M-5400), shown in Figure 9 with specification given in Table 4.

Vehicle service:	light-duty, man and material transport
Engine:	Kubota Model F2803-B
Engine displacement:	2.7 L
Engine Type:	4 cylinder, in-line, 4 stroke, mechanically controlled, naturally aspirated
Rated power:	55.5 HP @ 2700 rpm
Transmission:	Manual

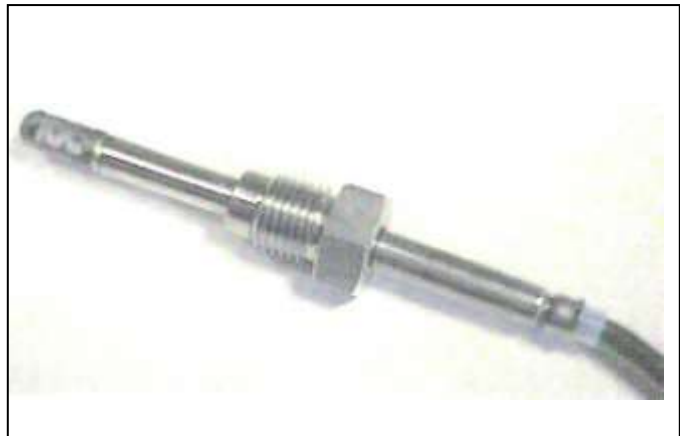
The temperature sensors, Figure 11 were Heraeus, type TS-200 EGTS, with a range of -40 to 1000 °C and an accuracy of $\pm 1.5\%$. The sensor tip was placed into the center of the exhaust stream through a female stainless steel A 182-68 nut, welded to the exhaust pipe. The signal sensitivity was $> 1\text{mV per } ^\circ\text{C}$.

Figure 11: Temperature sensor

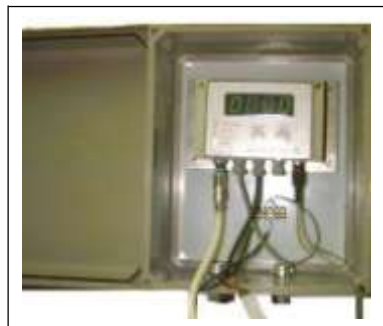
Figure 14: Data logger shown inside protective box with the cover off.

Model FCD-001 of the data logger from Paul Nöthiger Electronics is shown inside its protective case (made at Stobie) in Figure 14 and as received in Figure 15.

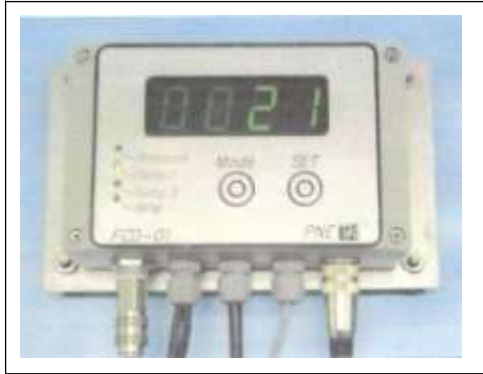
Figure 15: As-received data logger. The five I/O ports (left to right) are for pressure, two temperature sensors, engine rpm, power, and alarm outputs.

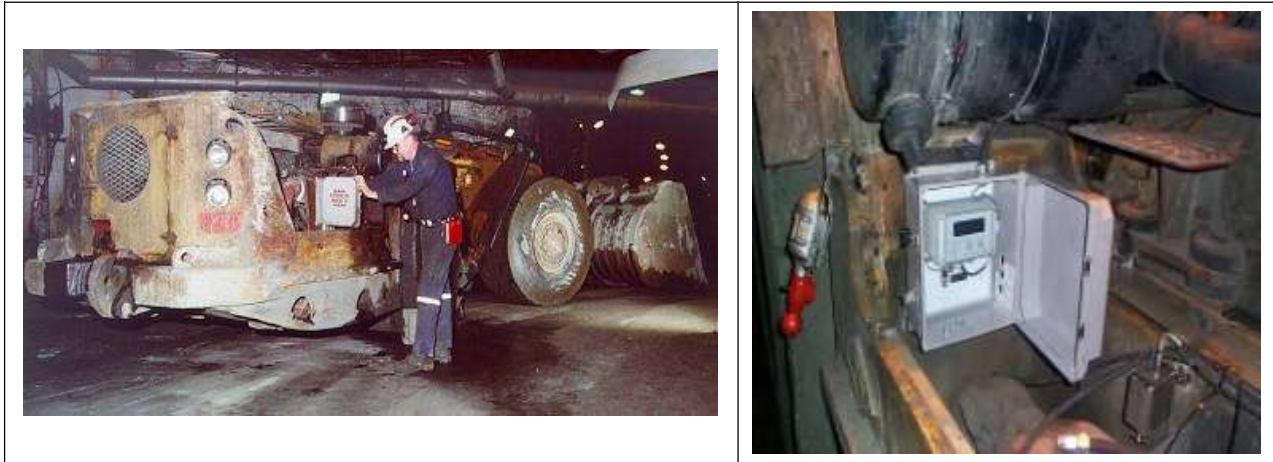
Figure 18: Installation of data loggers on LHDs.

Data logger installation was started in April 2000 during a visit to Stobie by P. Nöthiger and A. Mayer. The data loggers were positioned on each vehicle to allow reasonably easy access while not interfering with normal duties of the vehicle operator. Examples of data logger installations are shown in Figure 18 and Figure 19.

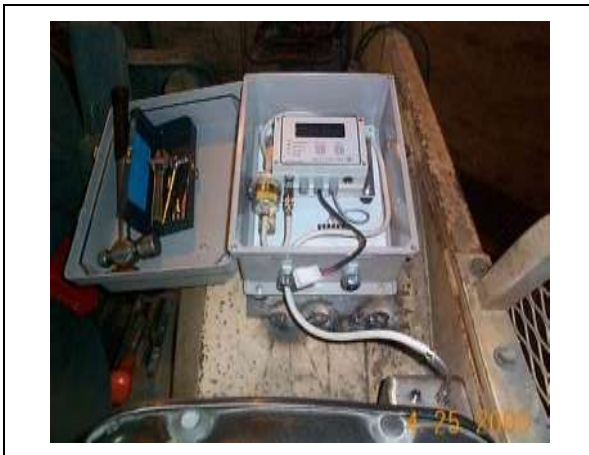
Figure 19: Installation of data logger just behind driver's seat on a Kubota tractor

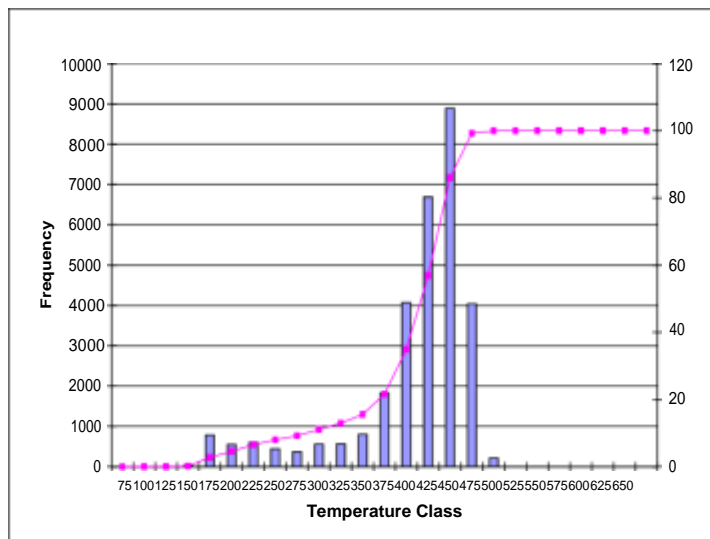
Figure 21: Simple temperature frequency distribution for data logged at 1 second intervals. Vertical bars show the number of observed temperatures in each temperature range. For example, the bar associated with the range 387.5 to 412.5°C temperatures in this range occurred just over 4000 times. The red points and line show the cumulative number of observations as a function of temperature as a percentage of total observations. For example, approximately 20% of the observations are $<375^{\circ}\text{C}$.

An example of a simple frequency distribution for these same temperature data is shown in Figure 21. The frequency distribution, however, must be interpreted cautiously. One cannot conclude, for example, that because 60% of the observations are above 400°C that these are exclusively the result of a number of continuous periods above this temperature. If this result is assumed, it could falsely lead believing that a passive DPF (using a catalyst) could be effectively regenerated by such temperatures. The flaw in reaching this conclusion is that the number of times the temperature is $>400^{\circ}\text{C}$ says nothing about the length of time the temperature stays above 400°C for each episode. That is, 4000 measurements in the range of $400^{\circ}\text{C} \pm 12.5^{\circ}\text{C}$ could represent a single episode containing a continuous 4000 seconds or it could represent 4000 different episodes where $>400^{\circ}\text{C}$ occurred for only 1 second, or it could represent anything in between these two extremes. It is known that successful passive regeneration of some DPF require a significantly prolonged episode of exhaust temperatures $>400^{\circ}\text{C}$. The simple frequency distribution fails to give the information critical in assessing the duty cycle for passive regeneration.

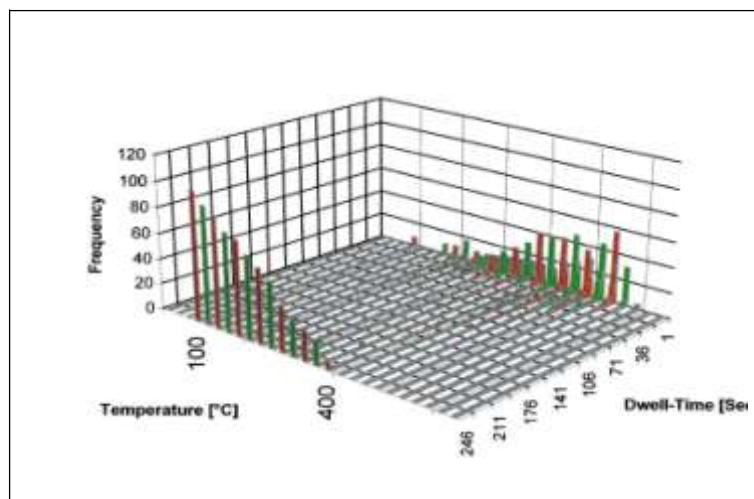
Figure 22: Temperature and dwell time frequency distribution for LHD #445 using 1 second data collection interval.

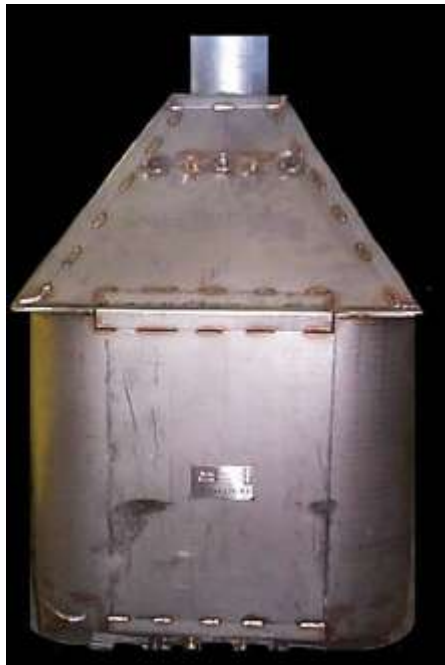
Figure 24: O-M housing containing eight filter cartridges.

Figure 23: O-M filter as installed on LHD #445.

The Oberland-Mangold (O-M) DPF system uses a deep bed filter element made of knitted glass fibers compressed between two perforated tubes to form cartridges. The required number of cartridges is assembled into a filter assembly as shown in Figure 24. The number of cartridges to be included in the DPF was determined by O-M using information on the diesel engine type, age and duty cycle. The unit was mounted on LHD #445 with DDEC 60 engine, Figure 23.

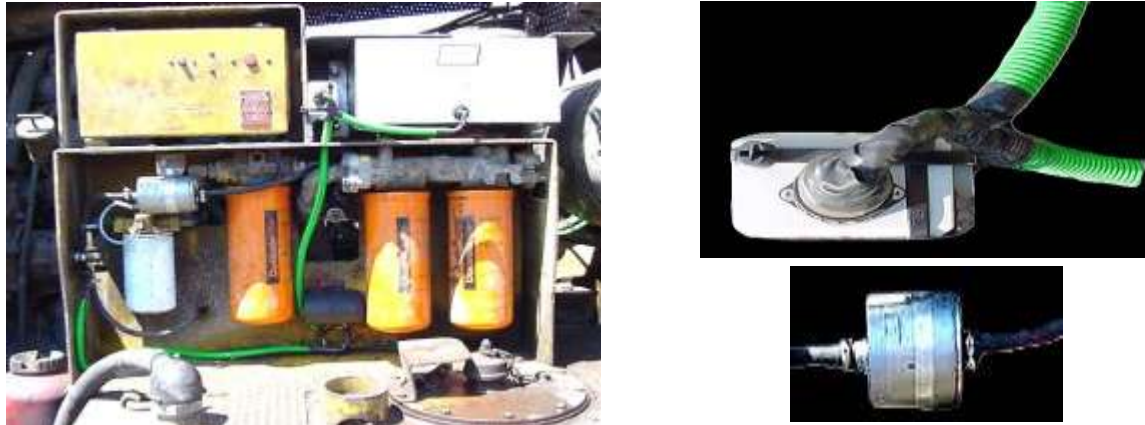
Figure 25: O-M FBC dosing components. Left: overall system; Upper right: electronic dosing control; Lower right: dosing pump.

The O-M DPF system used a FBC to promote passive regeneration. As part of the installation procedure, the engine was run for 3-4 hours using 1.27 L of the FBC for 376-379 L of diesel fuel, to fully coat the filter fibers with the platinum-based catalyst. Under normal operation the FBC was dosed automatically from a 12 L addition tank by means of a dosing control module, components of which are shown in Figure 25. A metal frame and guard was used to secure the FBC dosing system to the LHD chassis.

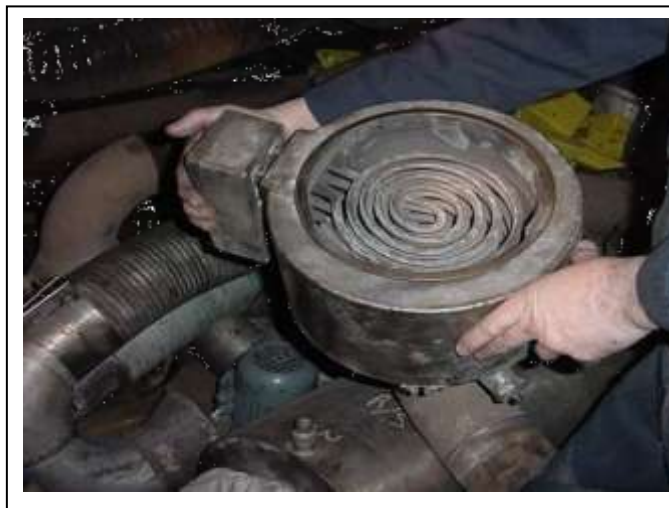
Figure 27: Heating element at the bottom of the JM DPF system.

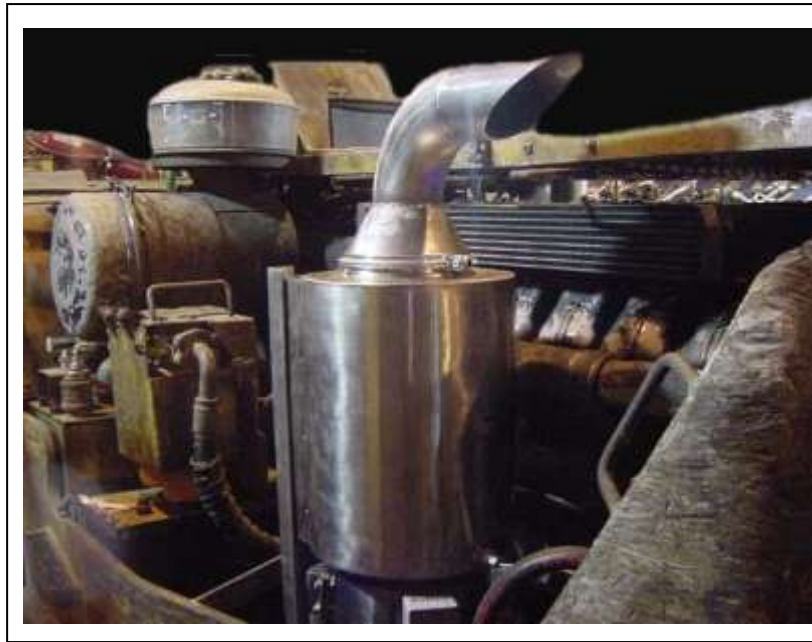
Figure 28: One of two JM filters mounted on either side of the dual exhaust Deutz V-12 engine.

The DPFs were installed vertically, using vibration-reducing mountings, on each side of the engine in place of the mufflers, as shown for one side in Figure 28.

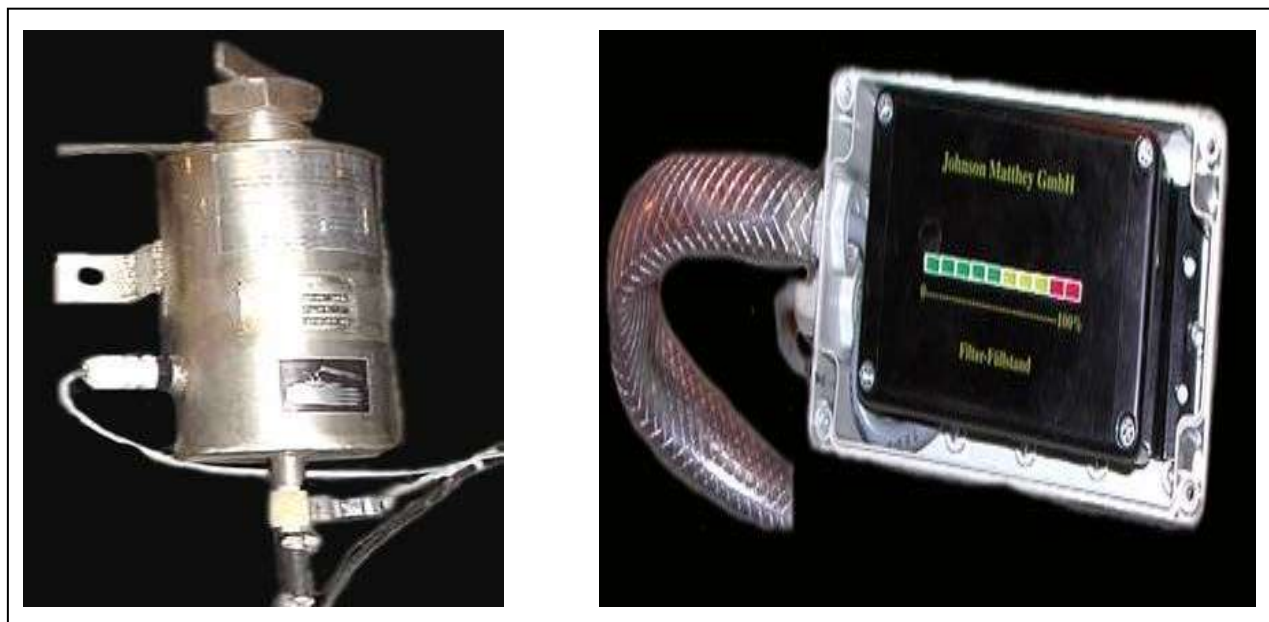
Figure 29: Automatic FBC dosing equipment (left) and backpressure monitoring display on dash (right).

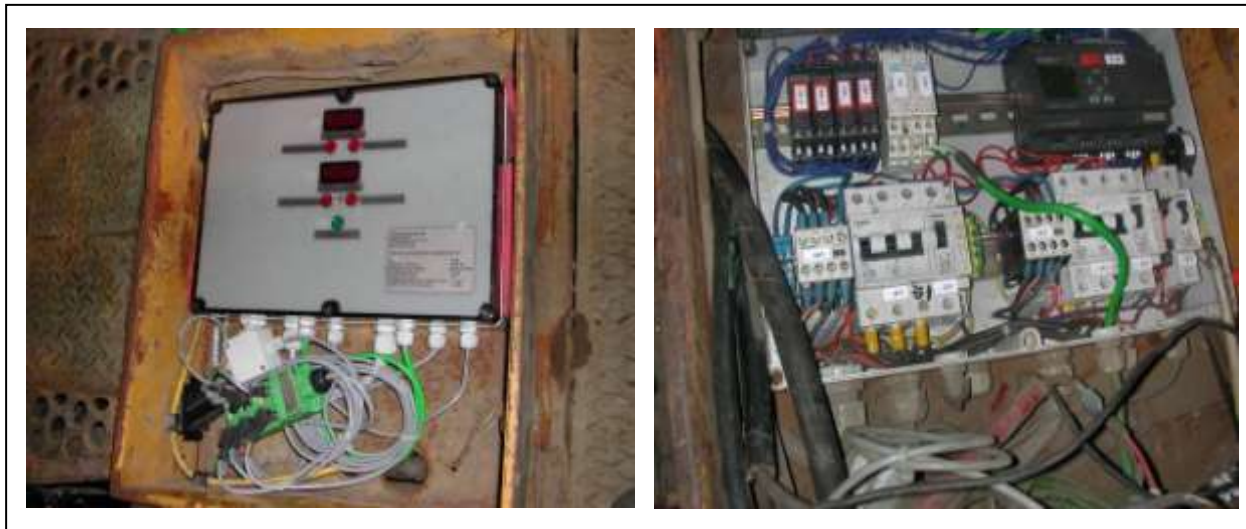
Figure 30: JM electric regeneration control display panel (on left) and interior (on right).

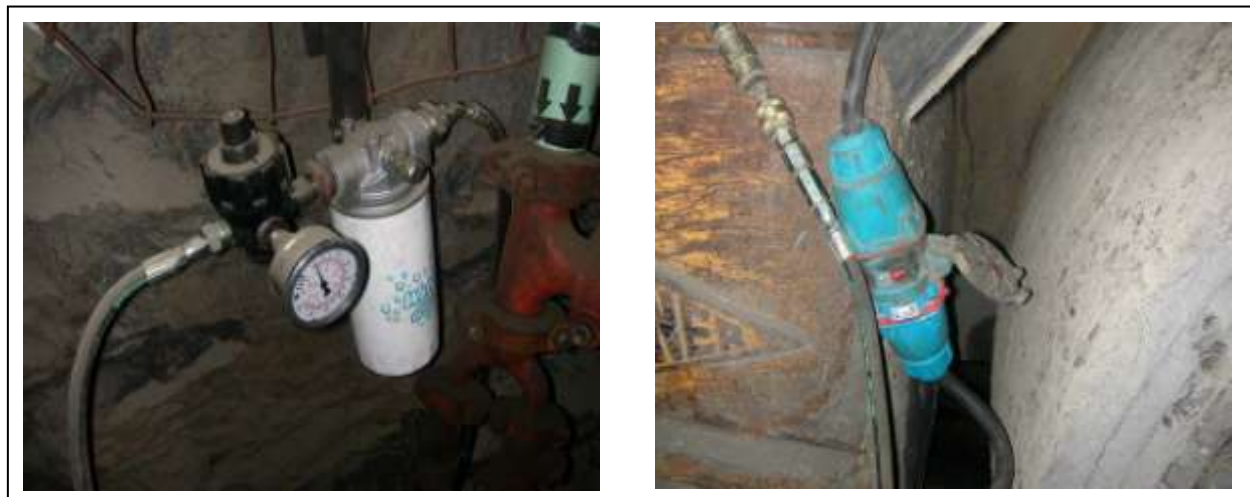
Figure 31: Air line with moisture removal and pressure gauge (left). The electrical connector (blue) and air line to its left (right).

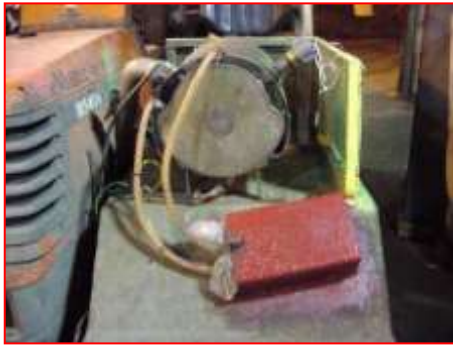
Figure 32: ECS/3M Omega filter mounted on tractor #2180. The yellow cage was to prevent operator contact with hot surfaces. The red box on the fender is a protective casing containing the power connector for electrical regeneration.

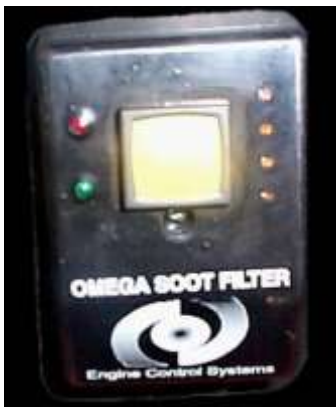
Figure 33: Omega dash display

The system had an exhaust backpressure monitoring system to monitor filter soot loading. The display, shown in Figure 33, has two sets of indicators: one contained a linear set of four LEDs that indicated backpressure, the other contained a single LED alarm light and audible alarm to indicate system failure or DPF plugging.

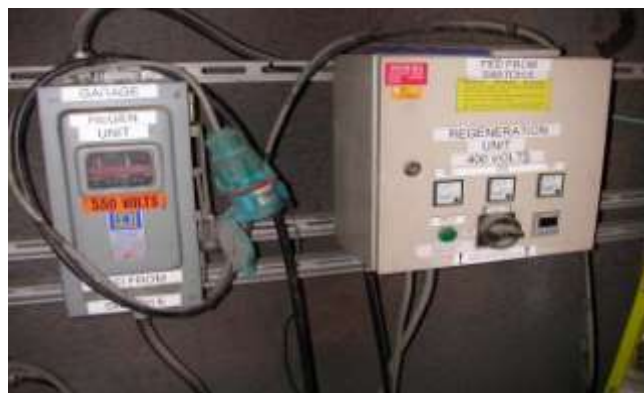
Figure 34: ECS/3M Omega regeneration station

The regeneration station for the system was inside the 1800 Level garage, Figure 34. This station controlled the timed air flow and power to the heating element. The 60 minute regeneration was to be conducted after each shift.

Figure 35 shows the ECS Combifilter mounted horizontally on the front fender of the #2180 tractor. The DPF consisted of a SiC wall-flow filter element with the addition of an electric heating coil built into the intake end of the DPF housing. The filter was sized to collect soot for a single 8-hour shift, and immediately thereafter was to be connected to the regeneration control station located inside the 1800 Level garage, Figure 34. The regeneration period under these conditions was about 60 minutes.

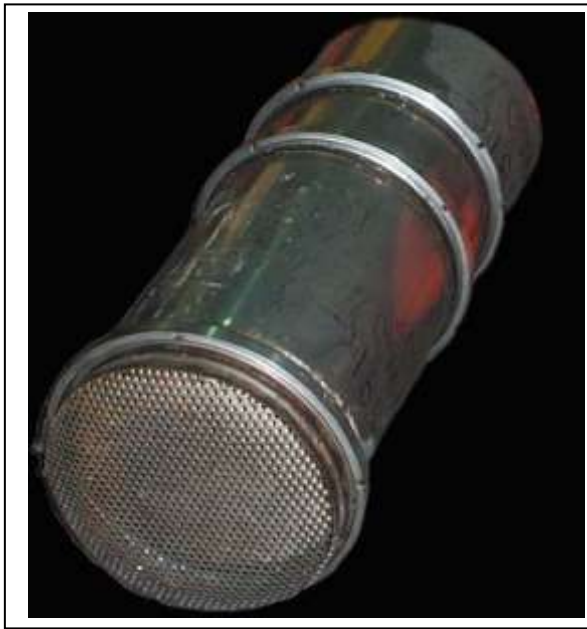
Figure 36: Engelhard DPX2 DPF system

The Engelhard DPX2 DPF system, Figure 36, was installed on LHD #362 (DDEC 60 engine) on 10 June 2001. This system was fully passive utilizing a cordierite wall-flow filter with a wash-coat of a platinum-based catalyst.

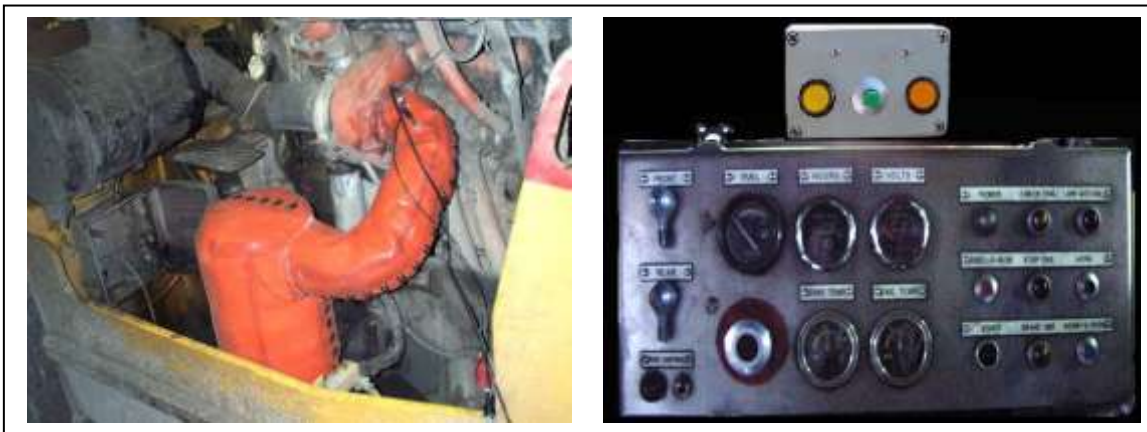
Figure 37: Engelhard DPX2 DPF as installed with insulation (left) and backpressure monitor on dash (right).

The installed system is shown in Figure 37, which also shows the dash-mounted backpressure indicator with yellow (warning) and red light displays.

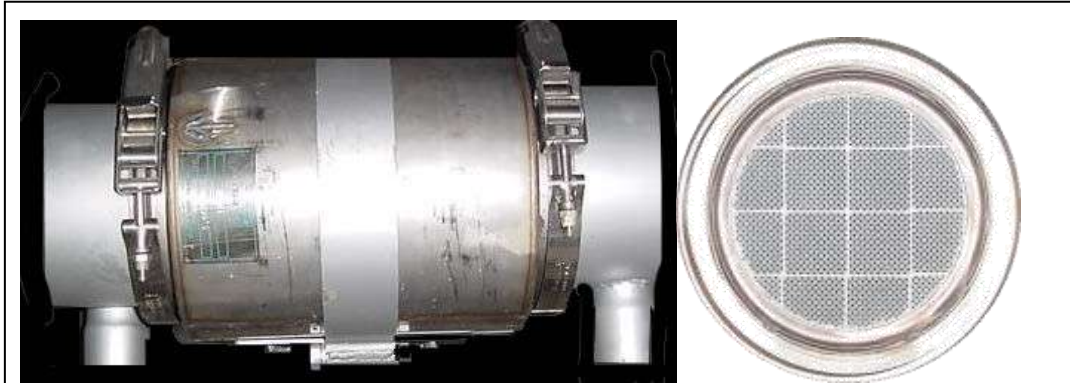
Figure 38: DCL Titan DPF, side view on the left and end view on the right. The side view shows the two end caps connected to the main canister by quick disconnect clamps.

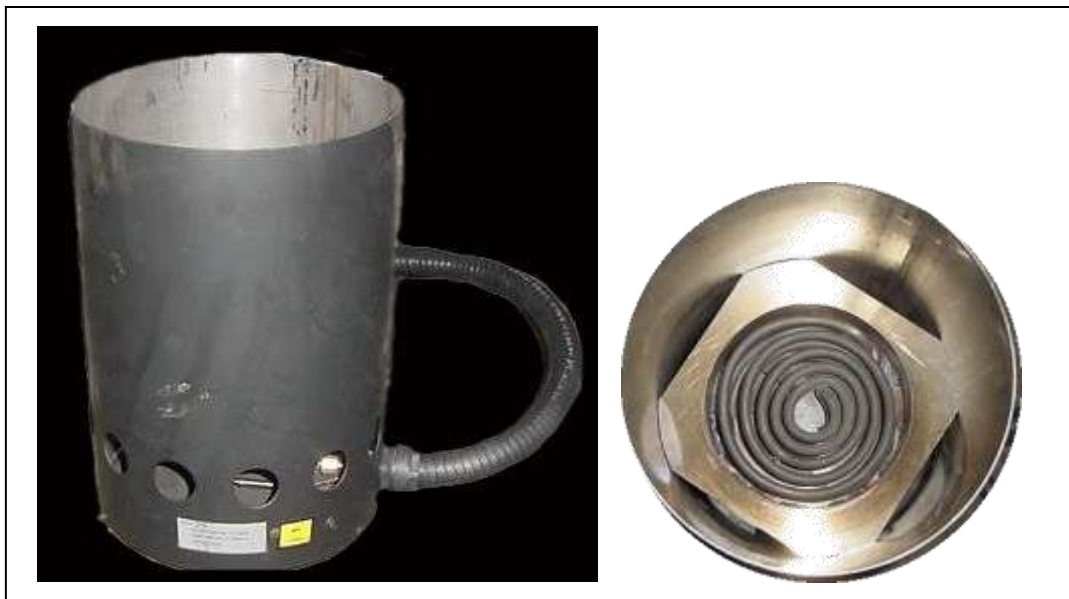
Figure 41: Regeneration "cooker" for DCL Titan DPFs: side view (left) and top view showing heater elements (right).

The regeneration control station was located inside the 1800 Level garage. Instead of plugging an on-board system into the power station, as was done for most of the DPF systems being tested at Stobie, the DCL Titan filter was removed from the vehicle and placed on top of the electric heating element within a cylindrical "cooker," Figure 41. The cooker was permanently connected to a wall-mounted power control panel, Figure 42. The control panel provided a timed regeneration cycle which typically lasted 1-2 hours. Natural convection supplied the air for soot combustion. After the heating cycle was completed, the filter was allowed to cool to room temperature before removing it from the cooker.

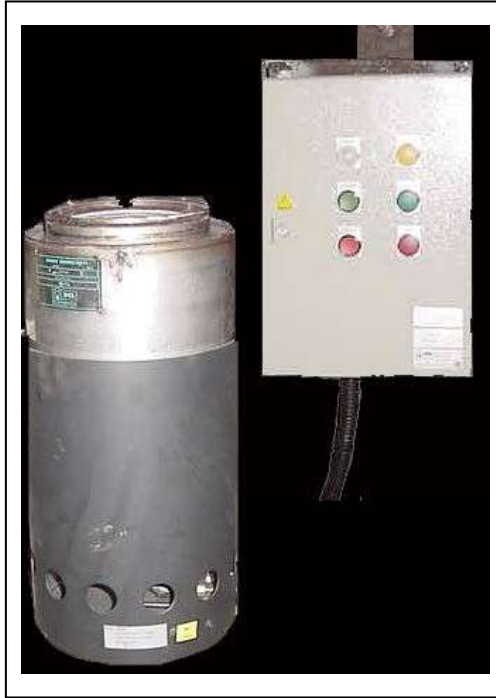
Figure 42: DCL Titan DPF regeneration station with a DPF placed in the cooker and cooker control panel (upper right).

Two identical DCL Titan DPFs were used for this tractor so that one DPF could be used on the operating vehicle while its companion DPF was being regenerated.

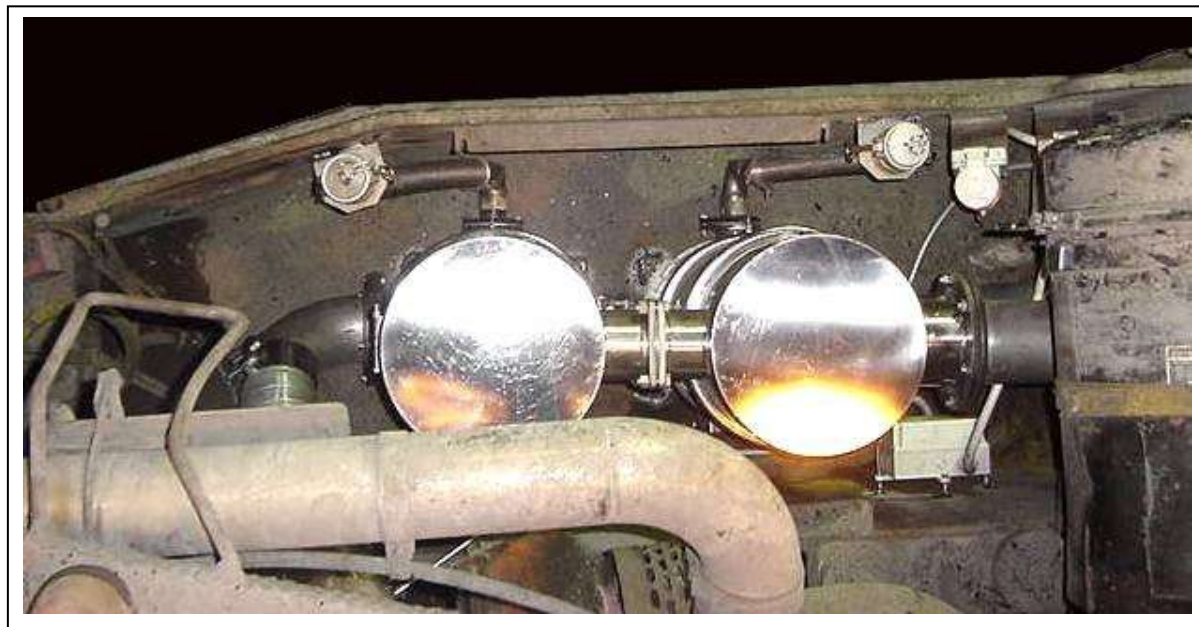
Figure 43: Top view of installed ECS Combifilters

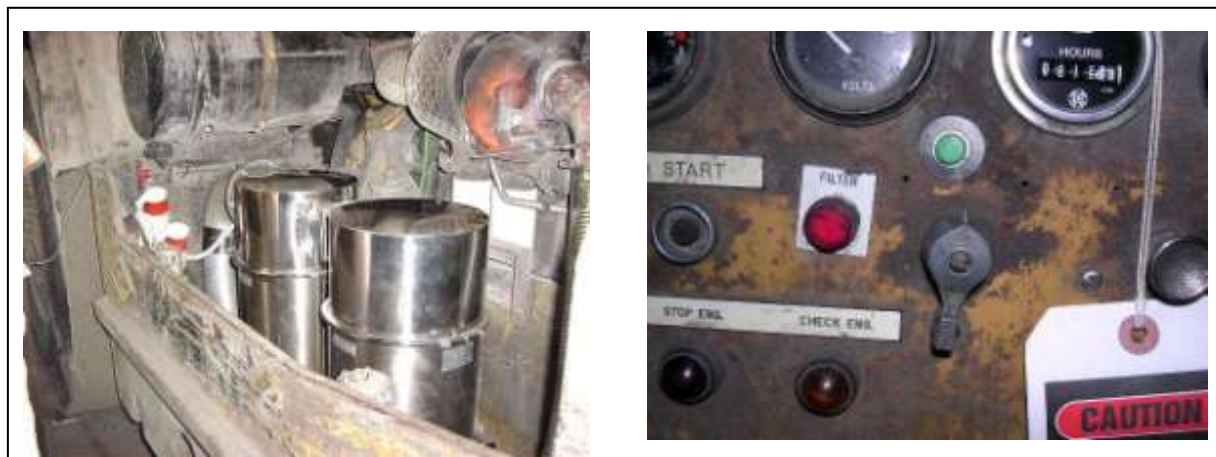
Figure 44: Side view of Combifilters (left) and backpressure monitor on dash (right).

The filters were sized to collect soot over two working shifts with active electrical heating regeneration performed each day. The dual filters operated in parallel. Two DPFs were used instead of one larger DPF due to spatial considerations, Figure 43 and Figure 44.

Backpressure monitoring was carried out by the DPF system. A dash-mounted, red LED indicated high exhaust backpressure and the need for regeneration, Figure 44 (right). A green “test” button was located next to the LED.

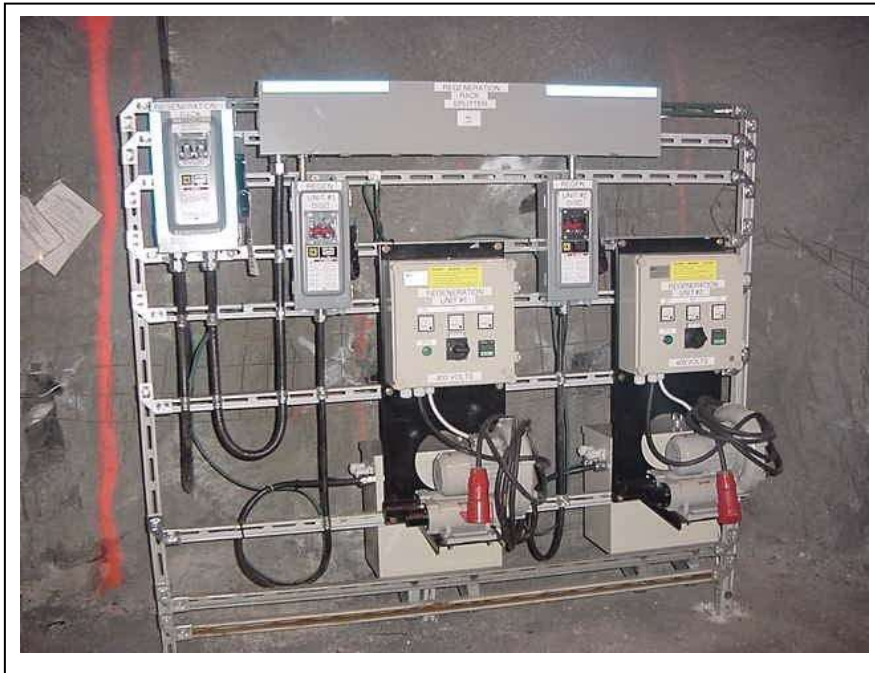
Figure 45: Regeneration control station for the DPF system using dual ECS Combifilters.

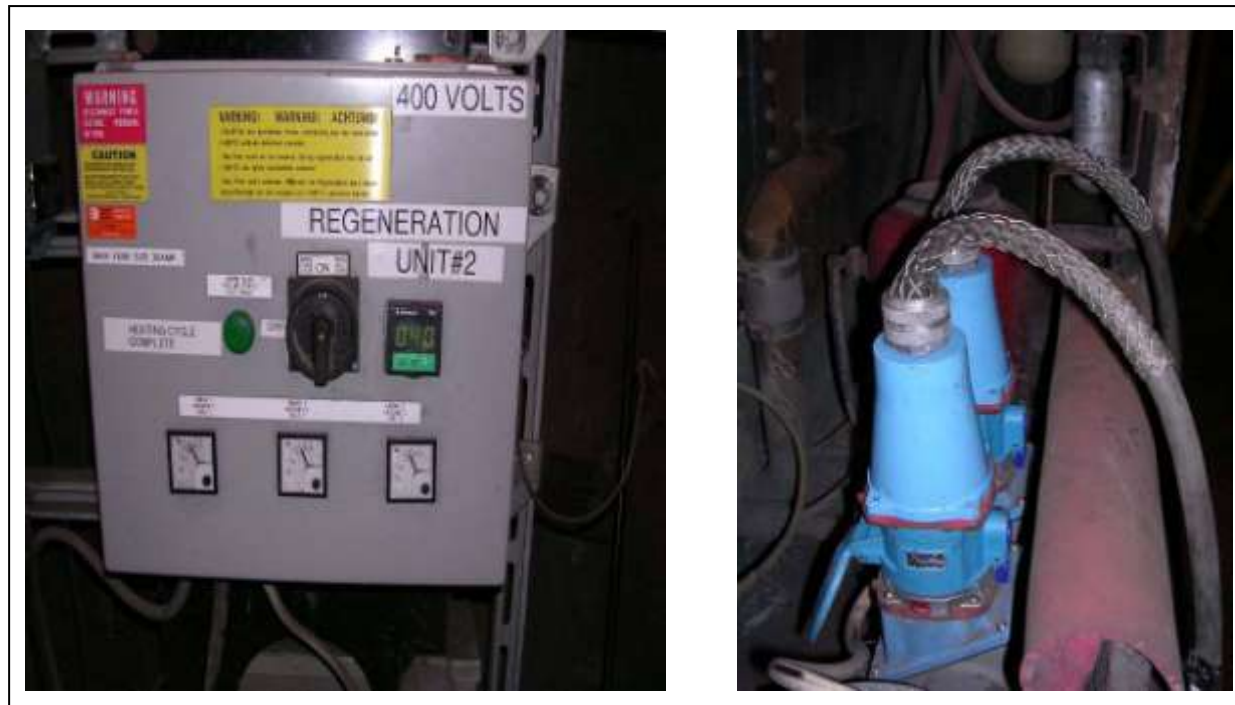
Figure 46: Regeneration control panel for one of the ECS Combifilters (left) and power cables connectors (right).

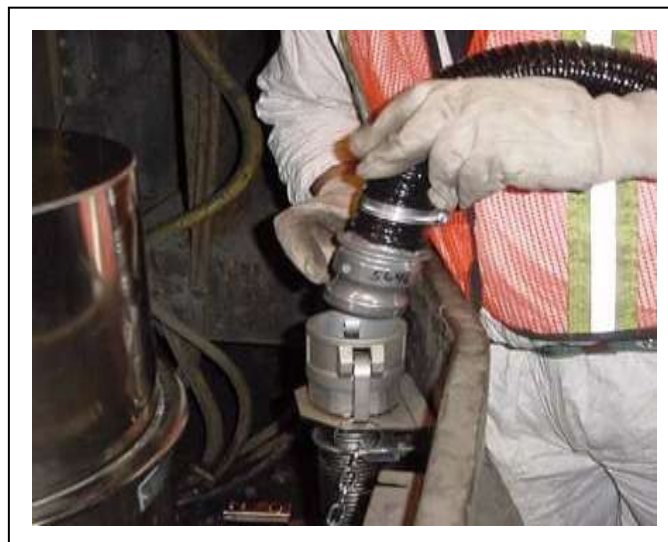
Figure 47: Compressed air connection.

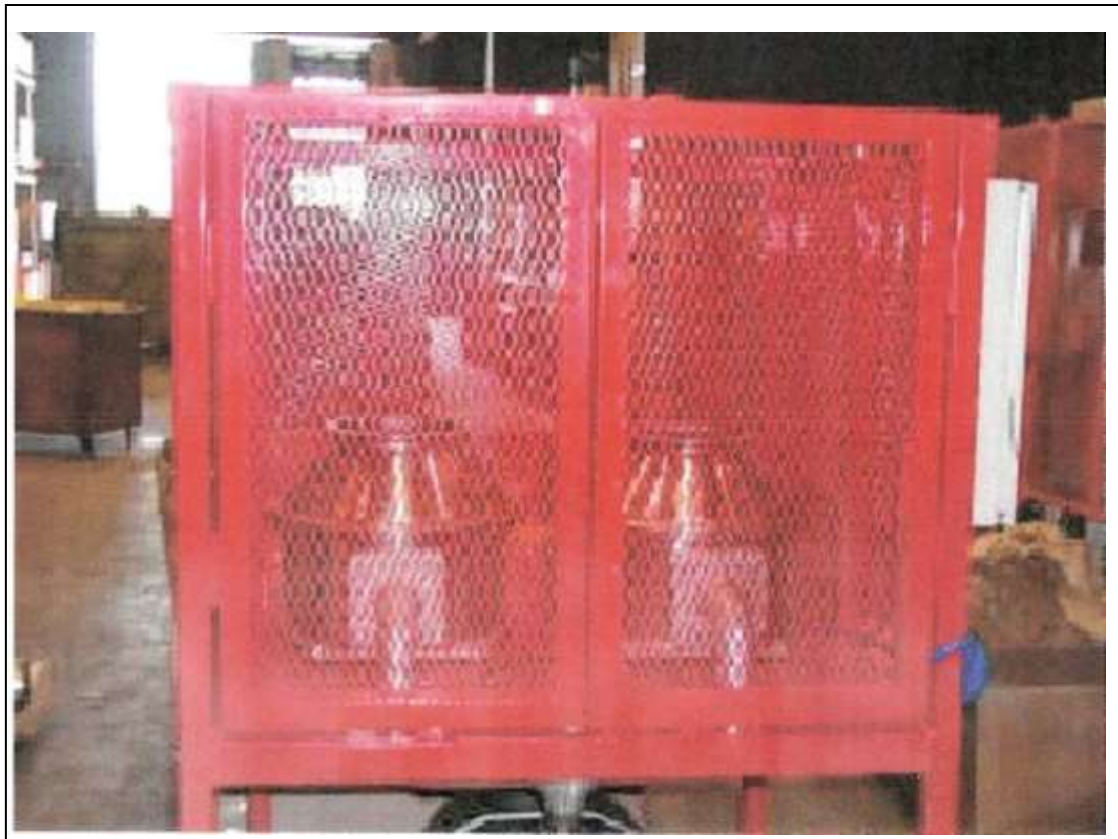
Figure 48: The ECS CombiClean™ DPF regeneration system, consisting of two heating compartments. Below what is shown is a shop type vacuum system (see Figure 50) used in conjunction with compressed air jet at the beginning of the regeneration process to remove the bulk of soot and ash.

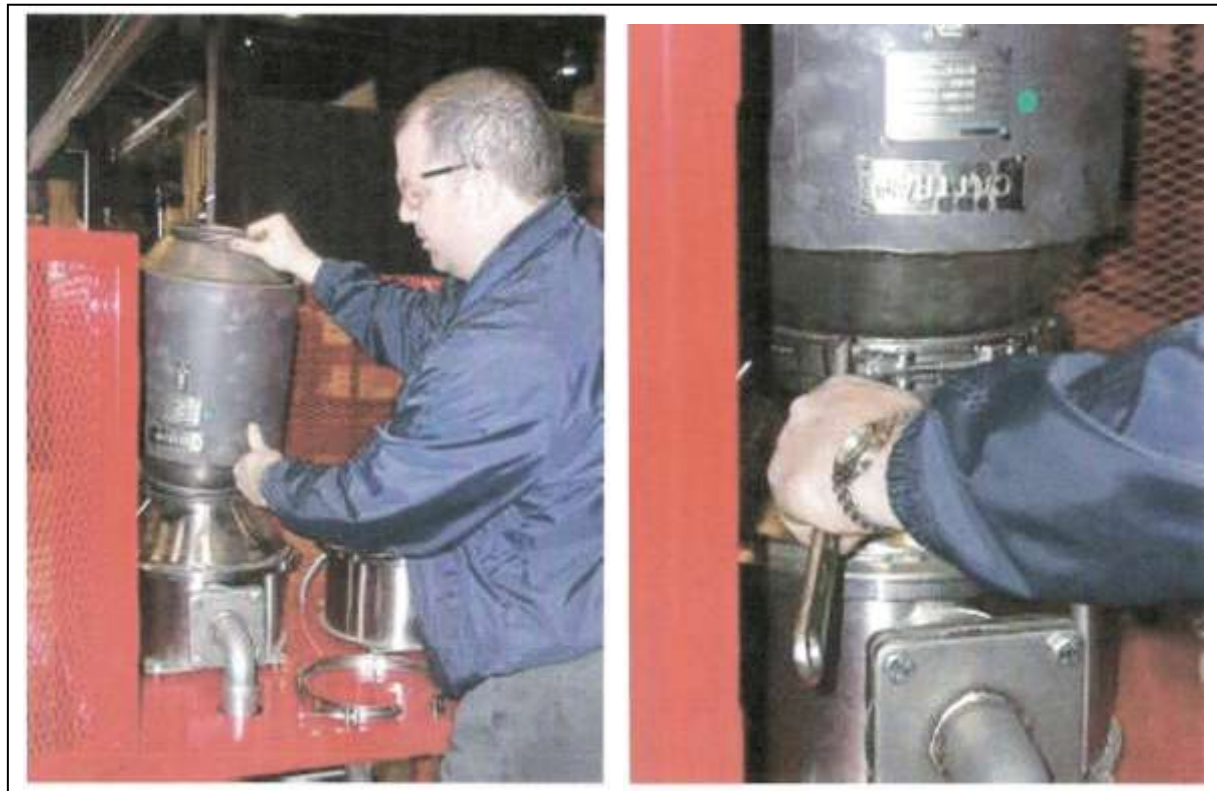
Figure 49: Mounting a loaded DPF on the CombiClean heater (left) and securing it with gasket and clamp (right).

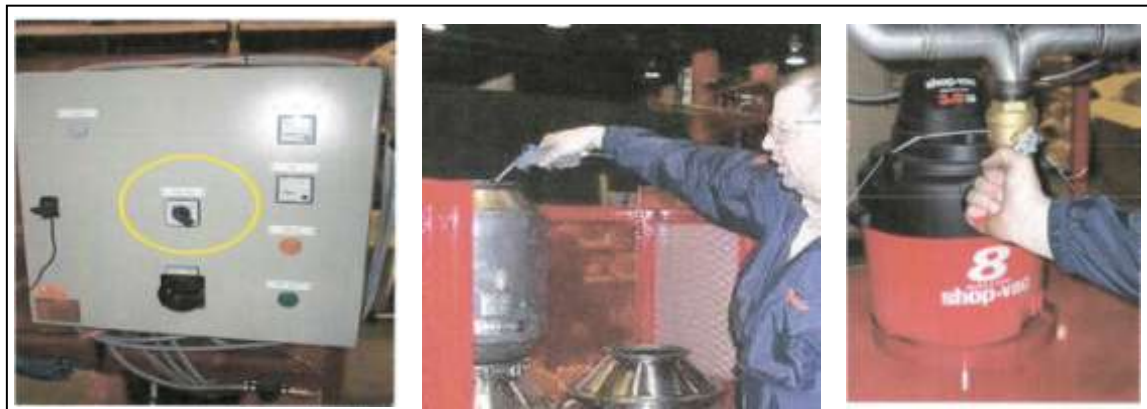
Figure 50: The CombiClean control panel (left), access for sweeping compressed air across the outlet side of the DPF filter element (middle) and vacuum system valve (right).

The loaded filters were carried to the CombiClean system and were securely mounted to the top of a heater unit using a gasket seal and clamp, Figure 49. Care was taken to orient the DPF so that the direction of exhaust flow through the DPF when mounted on the vehicle corresponded to the upward direction when the DPF was mounted on the CombiClean. The DPF was first cleaned by sweeping a jet of compressed air across the top of the exposed filter element while simultaneously operating the vacuum which provided a high reverse air flow so that residual soot and ash could be removed from the engine side of the filter. The control panel switch, Figure 50, was then used to activate the upward flow of combustion air and the heater. Lights on the control panel signified when the regeneration was complete.

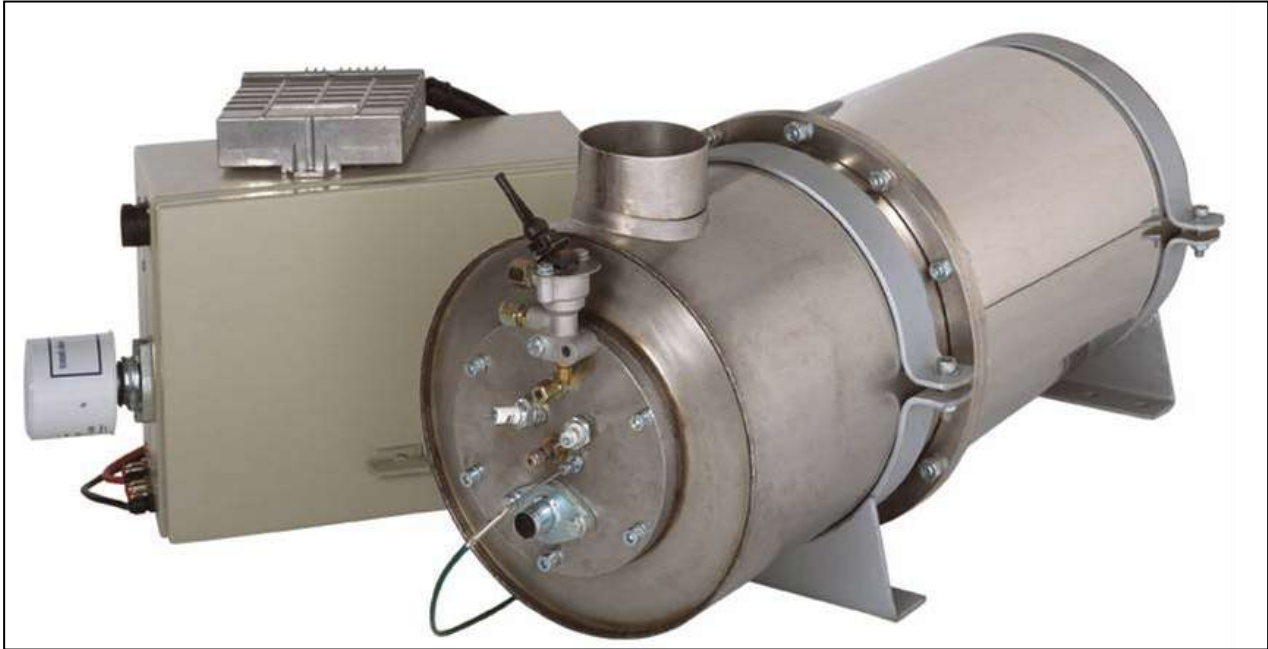
Figure 51: Arvin-Meritor PFS (horizontal position).

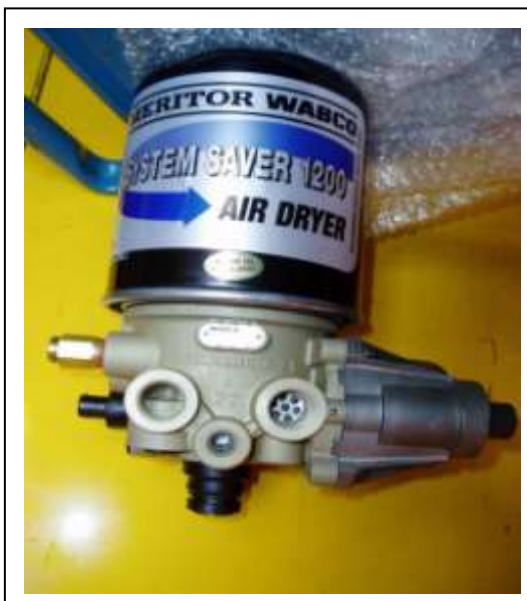
Figure 54: Air drier for burner

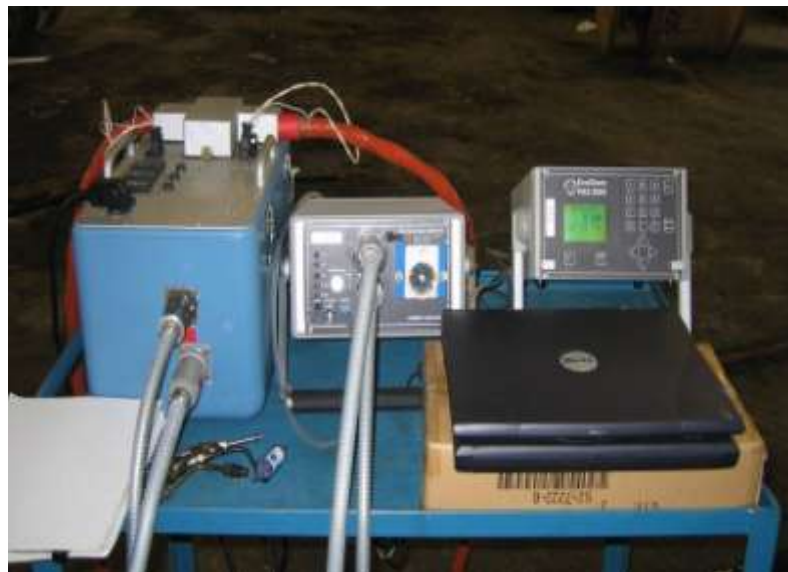
Figure 55: PAS 2000 photoelectric aerosol analyzer (on the right) with the dilution equipment on the left.

The photoelectric aerosol analyzer (PAS 2000) was used as one measurement of the soot (DPM) concentrations for the steady state engine modes^β. The PAS 2000, shown in Figure 55, developed by Matter Engineering (Wohlen, Switzerland) and

marketed by EcoChem (League City, Texas). The PAS is based on the detection of the ionized particles. Soot particles in diesel exhaust are typically elemental carbon (EC) particles with a layer of PAH adsorbed on their surfaces. When exposed to ultra-violet light, the PAH become ionized, resulting in positively charging the soot particle to which it is attached. The PAS exposes the sample stream to UV light and detects the flow of these charged particles as an electric current, which is proportional to the total particle surface area. Other work has shown a

The DPM particle concentration of the raw exhaust was too high for a direct measurement by the PAS 2000. The exhaust was therefore diluted using a spinning disk system from Matter Engineering, Model MD19-2E, Figure 55. Two heated sampling lines were used, one connected to the port upstream and the other placed in the exhaust stream downstream of the DPF (see Figure 59). The diluter was configured to allow quick switching between upstream and downstream sampling locations. The sampling lines were heated to 150 °F to prevent condensation of semi-volatile organics. The dilution ratios had to be adjusted occasionally for differences in soot concentrations over the various engine conditions being used, but all measurements were normalized to the dilution ratio of the measurement.

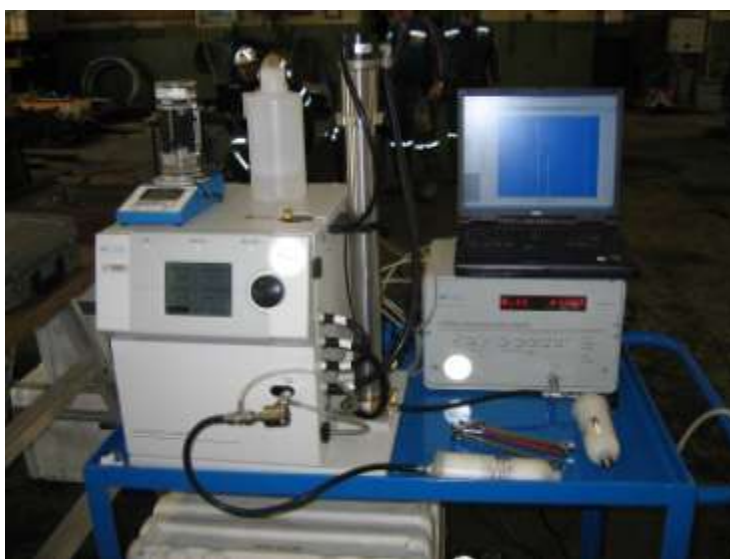
Figure 56: Scanning Mobility Particle Sizer.

The number concentrations and size distributions of particles between 10-392 nm were measured using a Scanning Mobility Particle Sizer (SMPS) from TSI Inc. (St. Paul, Minnesota), shown in

Figure 56. The SMPS was configured with a Model 3080L electrostatic classifier and a Model 3025A condensation particle counter (CPC). The sample and sheath air flows were maintained at 0.6 L/min and 6.0 L/min, respectively. At these flow conditions the instrument measures only aerosols with electrical mobility diameters (d_{em}) below 480nm. The CPC was operated in high-flow mode to minimize diffusion losses. The measurements were performed from the exhaust port located upstream and the exhaust stream downstream of the DPF systems (see Figure 59). In order to keep the aerosol concentrations below upper the measurement range of the SMPS, the exhaust was diluted using the spinning disk diluter described previously.
