Final Report
Version 2
September 2012

Evaluation of Diesel Particulate Filter Systems at Stobie Mine

Diesel Emissions Evaluation Program

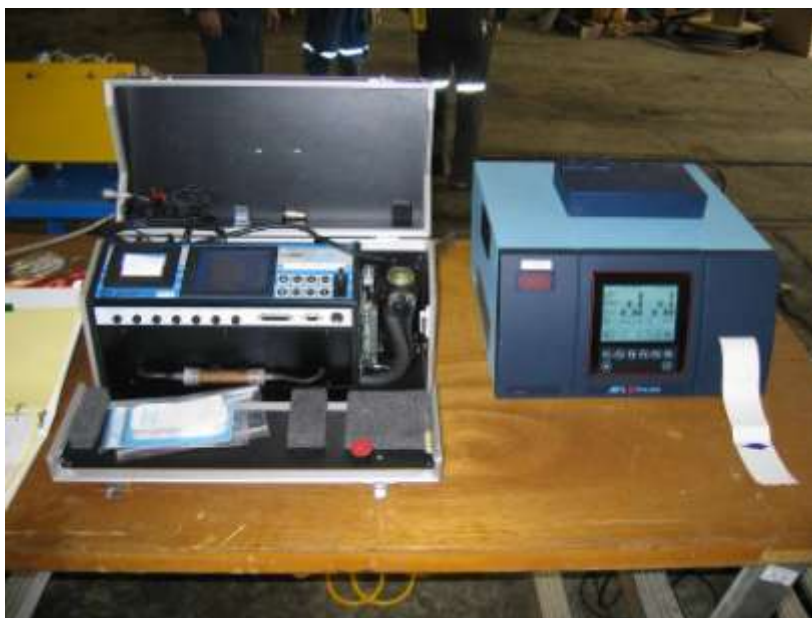
Figure 58: ECOM-KL gas analyzer (left) and the AVL Dicom 4000 (right)

The concentrations of the noxious target gases CO, NO, and NO₂, as well as CO₂ and O₂ were measured using ECOM KL and ECOM AC Plus portable analyzers from ECOM America (Gainesville, Georgia) shown in Figure 58. Two ECOM units were employed for the special tests with NIOSH because of the interest in comparing the results. Because only the ECOM-AC Plus

The AVL DiCom 4000 was used to measure exhaust opacity. The measurement is based on light transmission through the exhaust stream. The engine performed a snap acceleration while the AVL instrument detected the rpm increase and started the measurement. Once the instrument detected a steady high engine speed, it displayed the peak rpm and the opacity in percent. The following DPF opacities are generally recognized in assessing DPF performance:

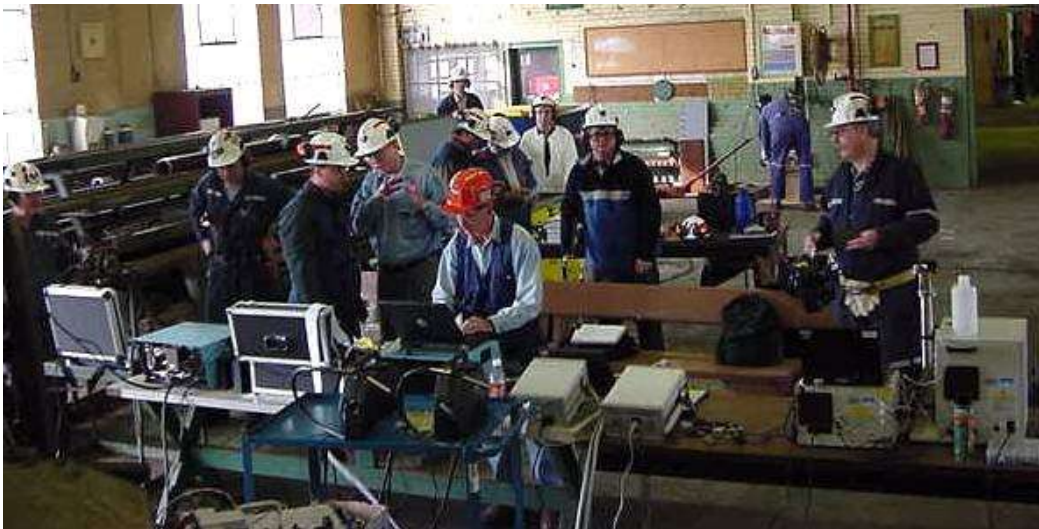
Figure 61: Equipment and crew set up in the Froid shop for conducting comprehensive testing.

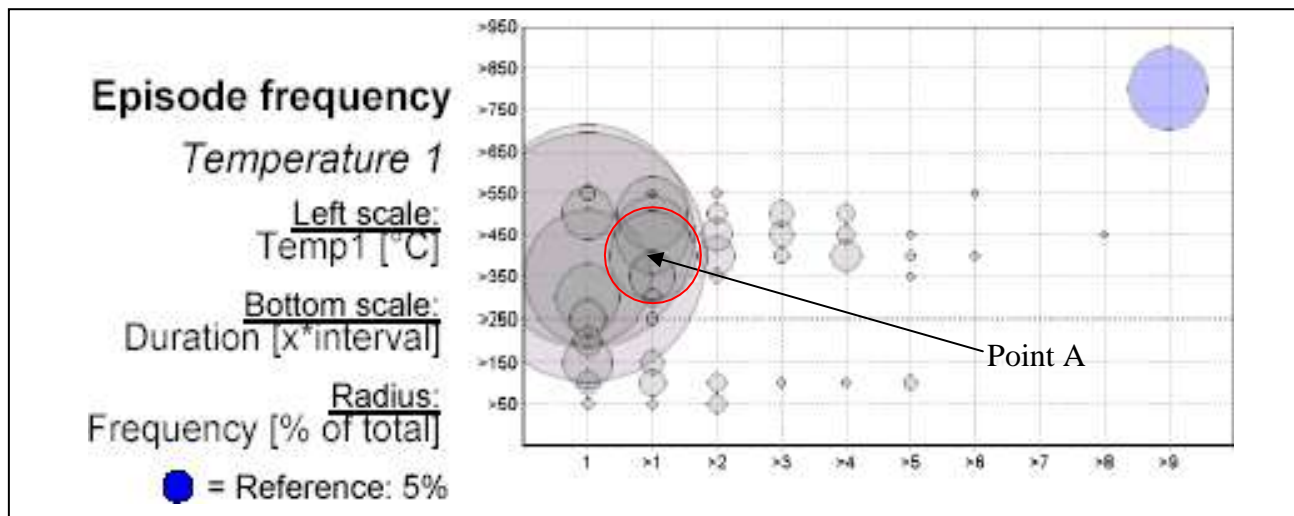
Figure 68: Example of a frequency distribution of temperature durations.

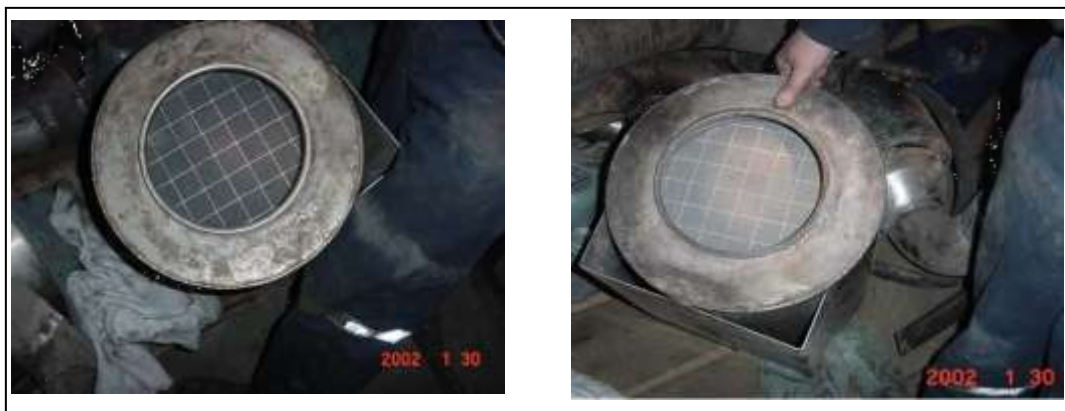
The inlet end and the discharge end of the Johnson Matthey filter before regeneration is shown in Figure 105. Clearly the inlet end is blackened with soot, as expected. The discharge end of the same filter is clean.

**Figure 105: The inlet side (left) and discharge side (right) of the Johnson Matthey DPF on left of LHD #820.**

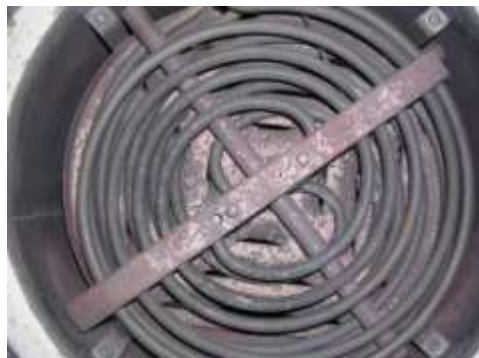
out for seven consecutive periods without removing the filter from the oven. The filter was then carefully removed so as not to jar loose any unburned soot. When the inside of the oven was examined, as shown in Figure 126, a fine white dust was visible on horizontal surfaces. Samples of this dust were removed using an eyedropper and were combined into a single ash sample.

Figure 126: Inside of oven after seven “cookings” of the ECS DPF.

A second sampling of ash trial was carried out on the ECS/Combifilter DPF on tractor #3013. An attempt was made to minimize the amount of unburned soot by handling the filter with great care as it was put into the CombiClean oven chamber. Then the cooking was carried

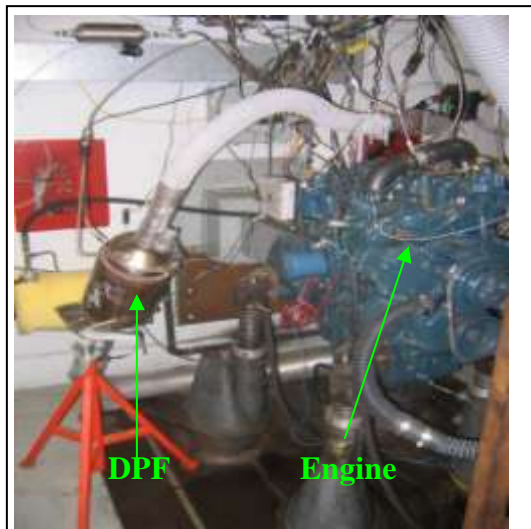
Figure 131: Filter being tested..

Particle size distributions were obtained using a Scanning Mobility Particle Sizer (SMPS) similar to the one described in Chapter 8. A NanoMet sampler (similar to that used to dilute raw exhaust samples by NIOSH as discussed in Chapter 8) was used with a photoelectric aerosol sensor (PAS) to obtain information about the EC portion of DPM.

Smoke opacity was measured with a Bosch RT 100 meter according to the SAC J1667 snap acceleration test protocol.

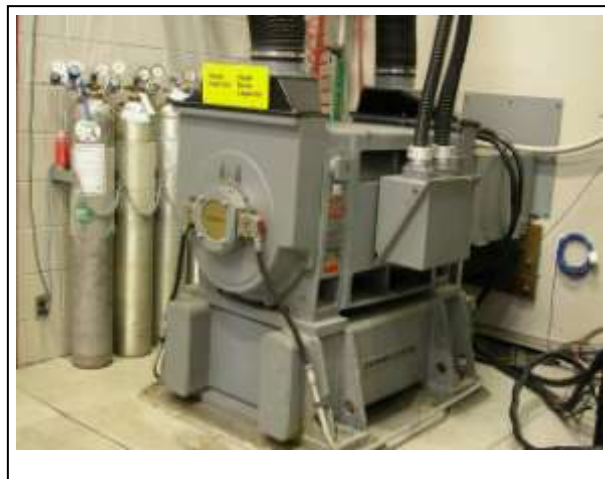
Figure 130: Dynamometer

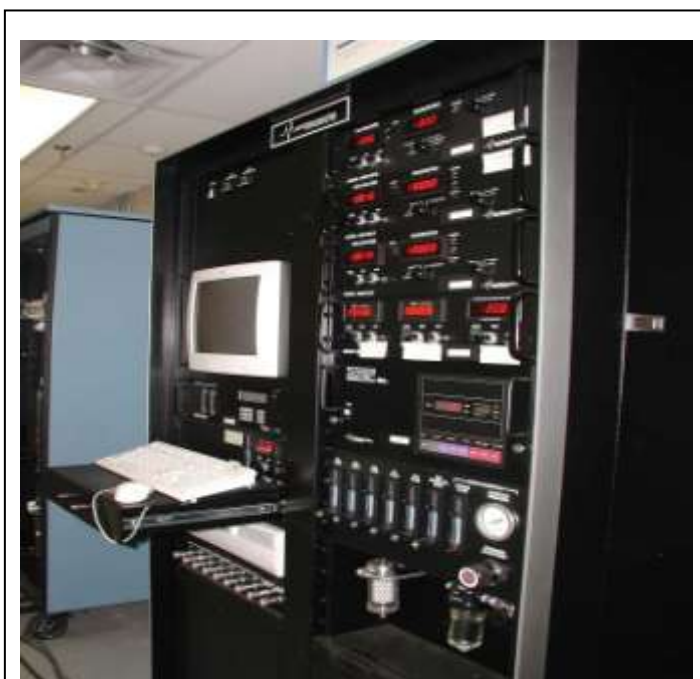
Figure 132: Raw gas analysis unit.

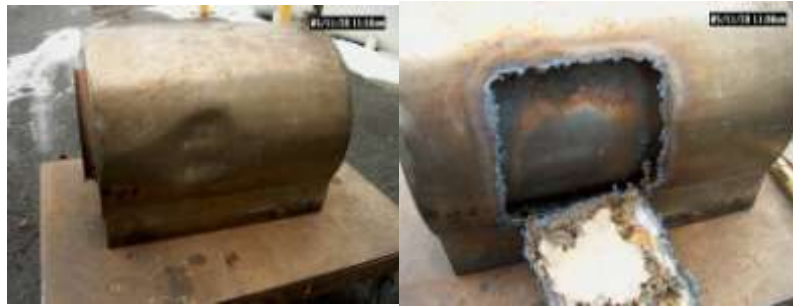
Figure 133: Johnson Matthey outer shell dent (right) and undamaged inner canister (left).

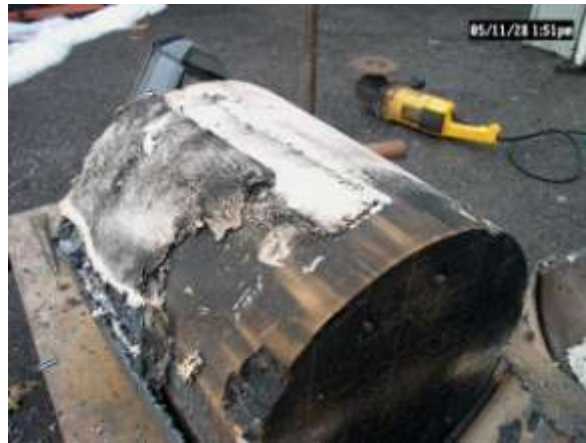
Figure 134: Degradation of mat holding J-M filter element in place.

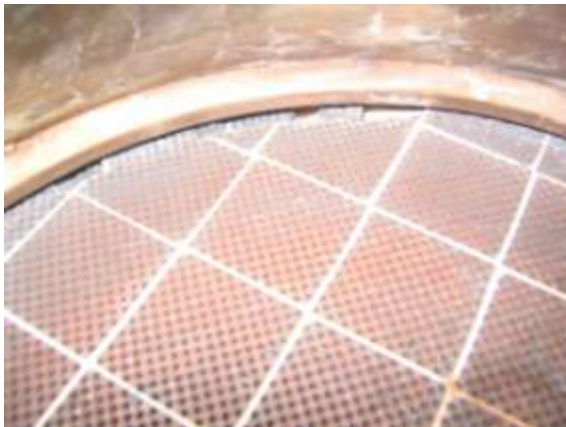
Figure 135: Separation of SiC filter from canister ring (top of photo).

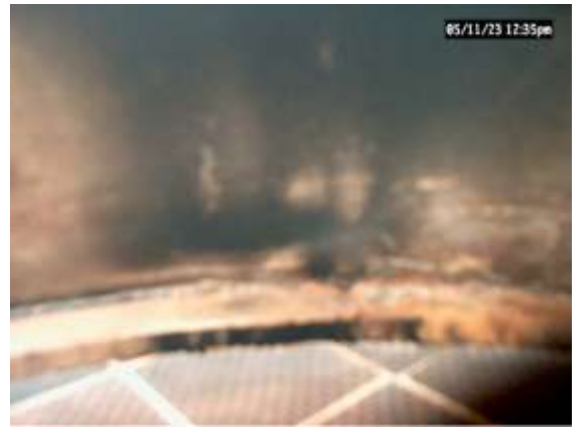
Figure 136: Blackened soot shadow at points of monolith separation indicating unfiltered exhaust bypassing filter.
