Final Report

Evaluation of Diesel Particulate Filter Systems at Stobie Mine

March, 2006

Diesel **E**missions **E**valuation **P**rogram

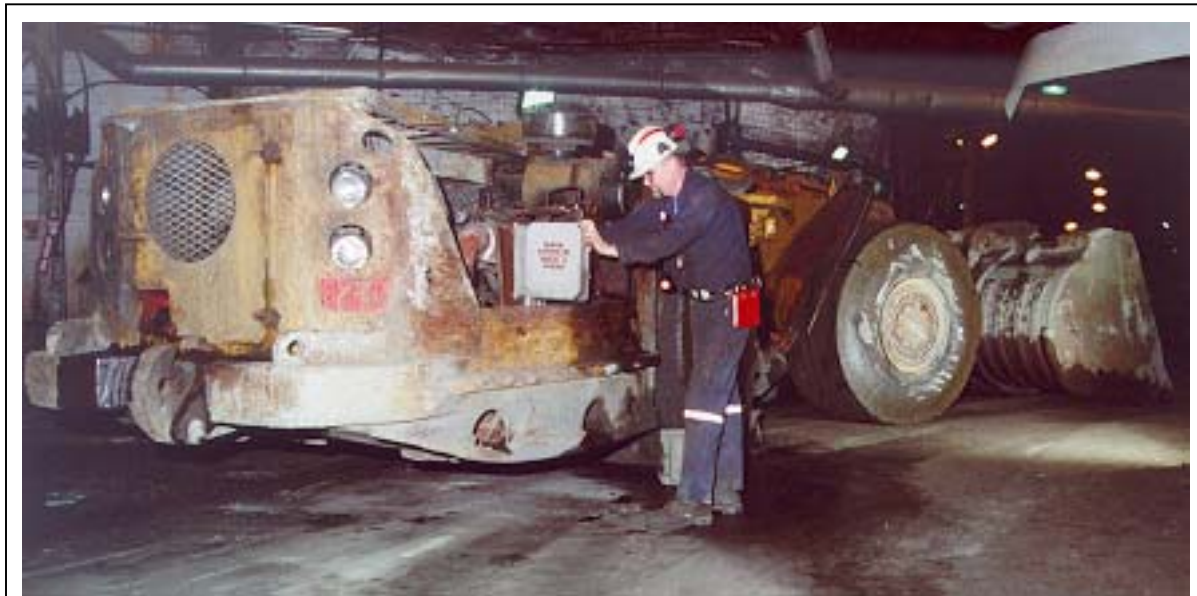
Vehicle used as:	heavy-duty, load-haul-dump
Engine:	Deutz F12L413FW
Engine displacement:	19.14 liters
Engine Type:	12 cylinders, V configuration, 4 stroke, mechanically controlled, turbocharged
Rated Power:	280 HP @ 2300 rpm
Transmission:	automatic

Figure 7: Wagner ST8B scooptram with Deutz engine (vehicle #820)

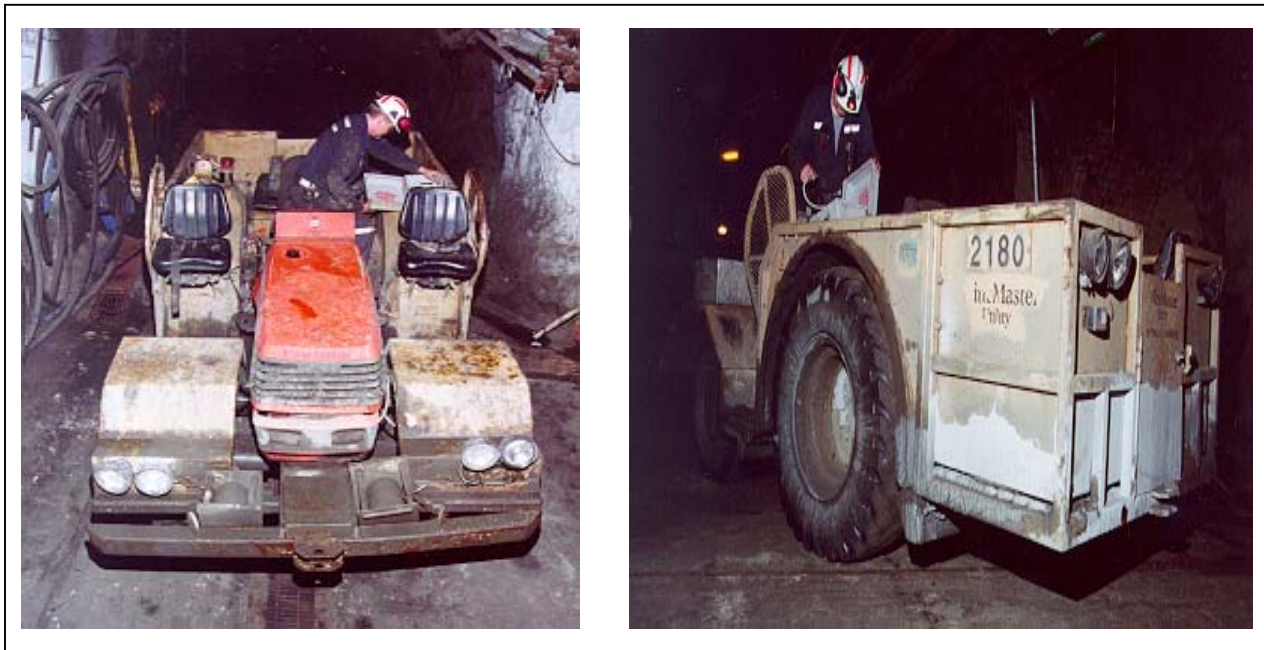
Vehicle # 621 : Kubota Tractor (M-5400), shown in Figure 9 with specification given in Table 4.

Vehicle used as:	light-duty, man and material transport
Engine:	Kubota Model F2803-B
Engine displacement:	2.7 liters
Engine Type:	4 cylinder in-line, 4 stroke, mechanically controlled, naturally aspirated
Rated power:	55.5 HP @ 2700 rpm
Transmission:	Manual

Figure 9: Kubota tractors #621(left) and #2180 (right).

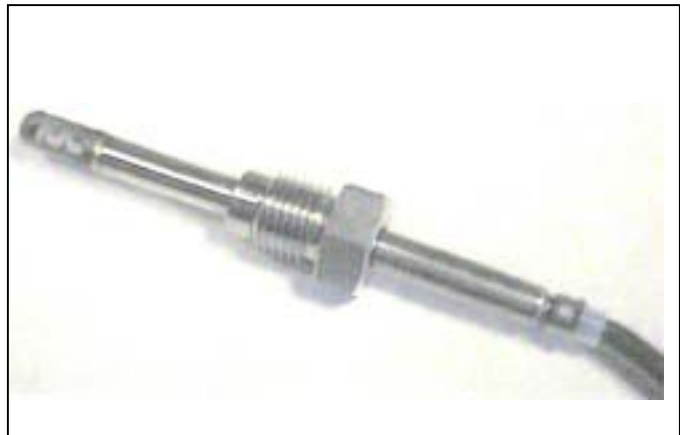
The temperature sensors were type TS-200 EGTS from Heraeus, shown in Figure 11. The sensor, connected to a male connector, fit into a female stainless steel A 182-68 nut, which was welded onto the exhaust manifold. This sensor was able to operate between -40 to 1000°C with an accuracy of $\pm 1.5\%$. The signal sensitivity was $> 1\text{mV per }^{\circ}\text{C}$.

Figure 11: Temperature sensor

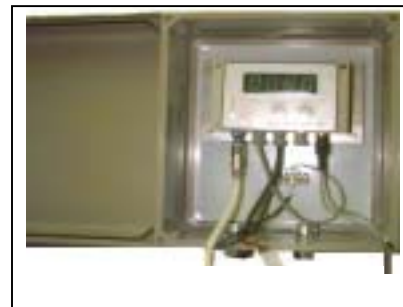
Model FCD-001 of the datalogger from Paul Nöthiger Electronics is shown inside its protective case (made at Stobie) in Figure 14 and as received in Figure 15.

Figure 14: Datalogger inside protective box.

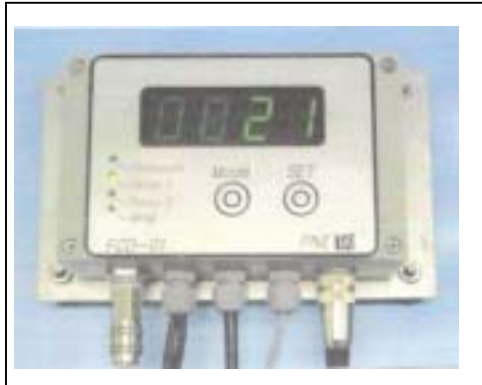
Figure 15: As-received datalogger. The five I/O ports (left to right) are for pressure, multi-use temperatures-rpm, power, and power alarm.

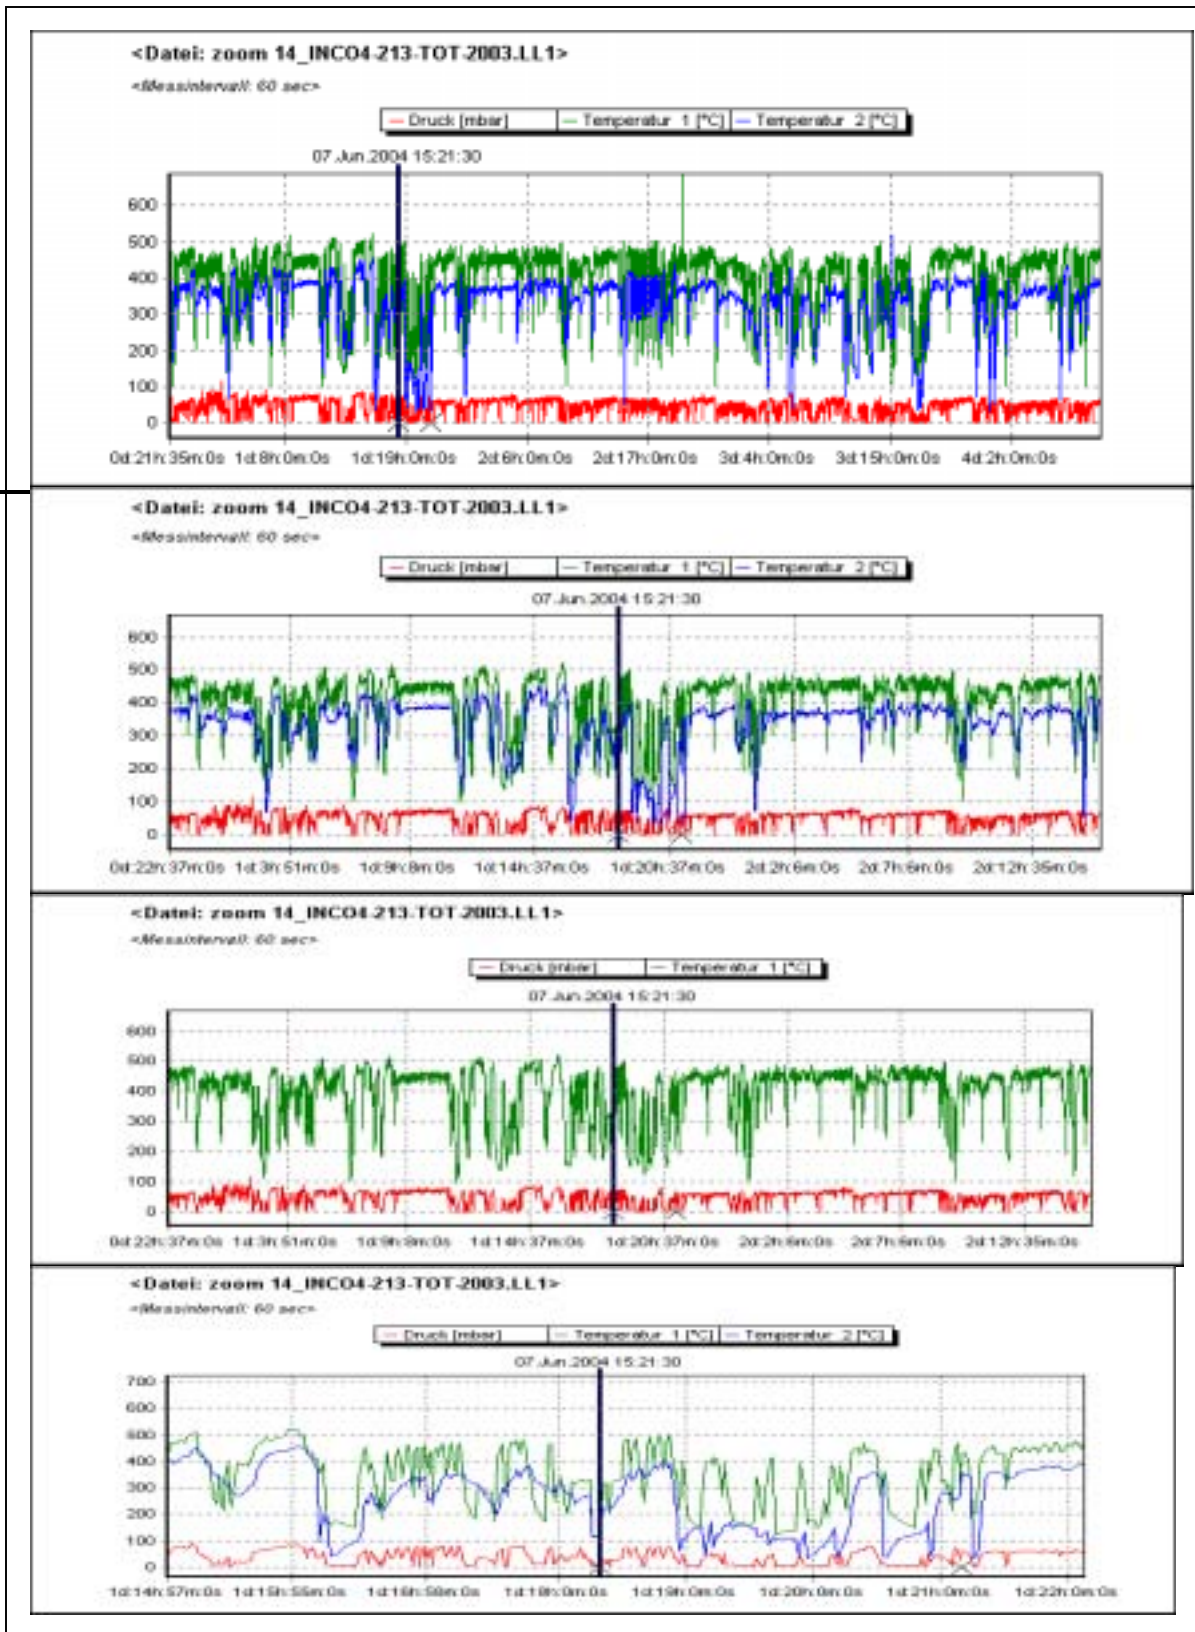
The Graphics menu could display either direct LogLink data or ASCII data as a function of time. A zoom feature allowed closer inspection of information. An example of graphical information is shown in Figure 17.

Figure 17: Data displays showing zoom capabilities. All the four displays are taken from vehicle #213 around June 7, 2004. A common time of 15h:21m:30s is shown in each display by a solid vertical black line. The three parameters shown are inlet temperature (green), outlet temperature (blue) and overpressure (red).

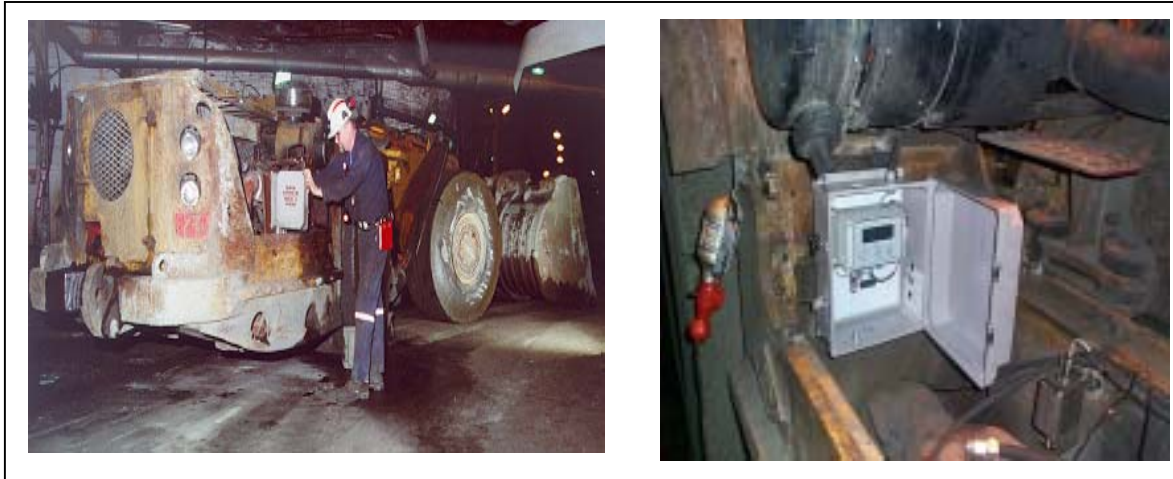
Datalogger installation was started in April 2000 during a visit to Stobie by P. Nöthiger and A. Mayer. The position of the datalogger on each vehicle was done to allow reasonably easy access while not interfering with normal duties of the vehicle operator. Examples of datalogger installations are shown in Figure 18 and 19.

Figure 18: Installation of dataloggers on LHDs.

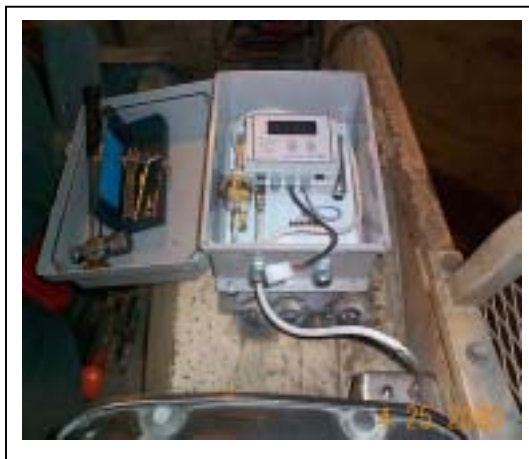
Figure 19: Installation of datalogger just behind driver's seat on Kubota tractor

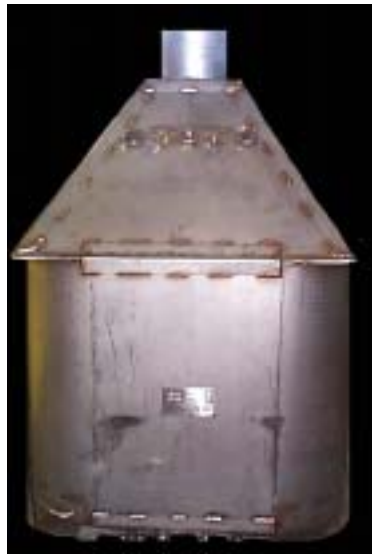
The filter medium of the Oberland-Mangold system is a mesh of ceramic micro-fibers, which act as a deep-bed filter for soot particulate. These fibers are compressed between two perforated tubes and canned in cartridges. All the cartridges are assembled into the filter assembly as shown in Figure 23. The number of cartridges to be included in the PFS was determined by Oberland-Mangold using information on the diesel engine type, age and duty cycle. The unit was mounted on LHD #445 as shown in Figure 24.

Figure 23: Oberland-Mangold casing containing eight filter cartridges.

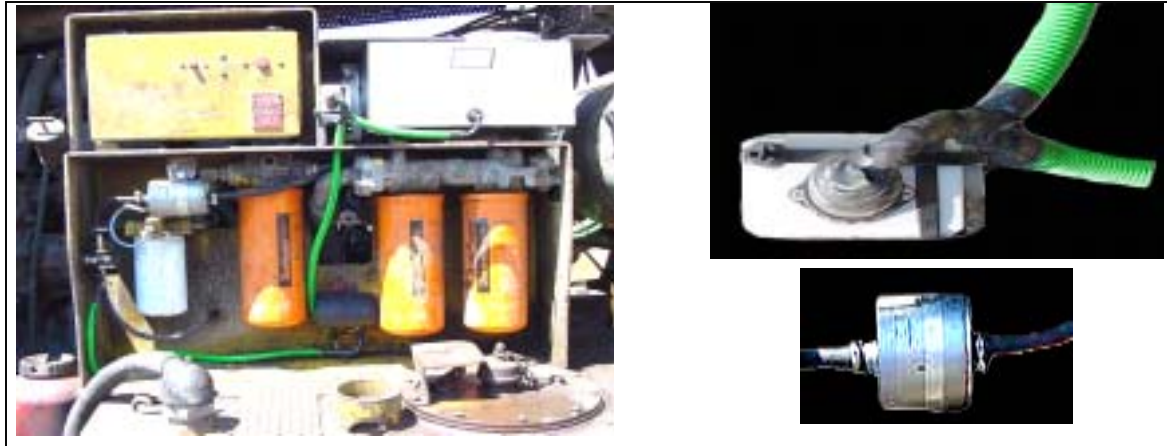
Figure 25: Oberland-Mangold fuel additive components. Left: overall system; Upper right: electronic additive control; Lower right: additive pump.

Oberland-Mangold on an LHD: This system was complex due to the controls needed to regulate pumping the fuel-borne catalyst into the vehicle's fuel tank. Despite considerable team resources being used to install the system according to the manufacturer's criteria, and despite an intensive week of training of two Stobie mechanics in Germany, the system showed very inefficient filtration of soot, ranging from 3-70% and downstream smoke numbers of 5.5 compared to 7.0 upstream. The system was deemed to have failed with essentially zero hours of operation.

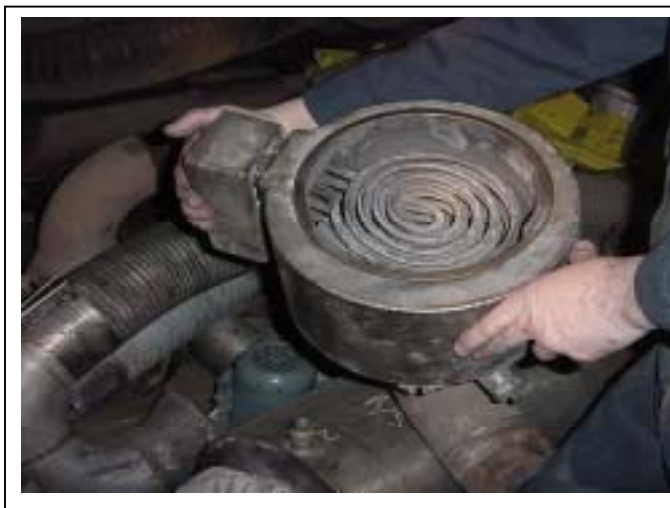
The canisters were stainless steel construction with modular design, having V-clamps and gaskets for easy assembly and servicing. Within the inlet stage, there existed a diffusion plate that provided even distribution of particulate-laden gases over the filter honeycomb. The heating element stage, Type EC-B/Ca, shown in Figure 27, consisted of electric heating elements with power and air supply connections. The air flow during regeneration assisted in obtaining the optimum heat distribution to the filter's mass.

Figure 27: Heating element at the bottom of the Johnson-Matthey filter.

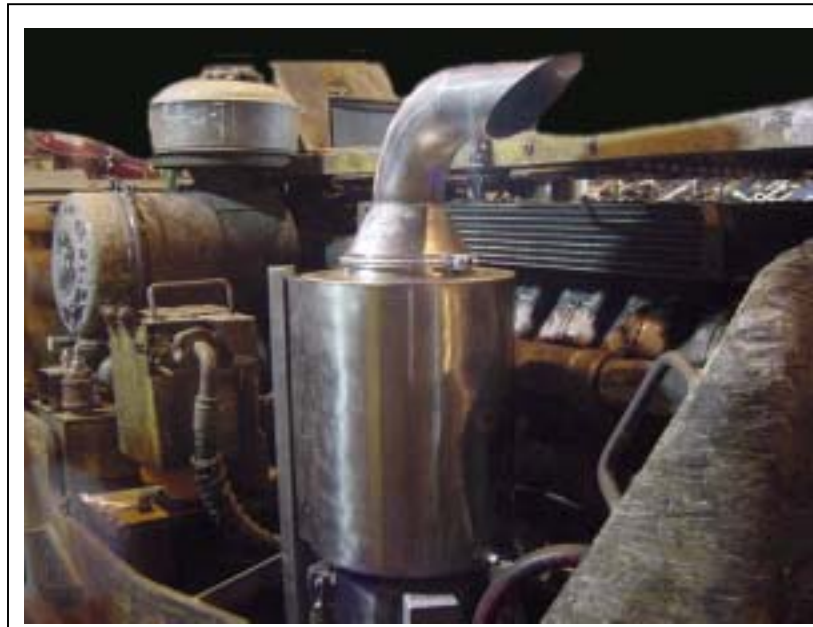
The cylinders were installed vertically, using vibration-reducing mountings, on each side of the engine in place of the mufflers, as shown for one side in Figure 28.

Figure 28: One of two JM filters mounted on either side of the dual exhaust engine.

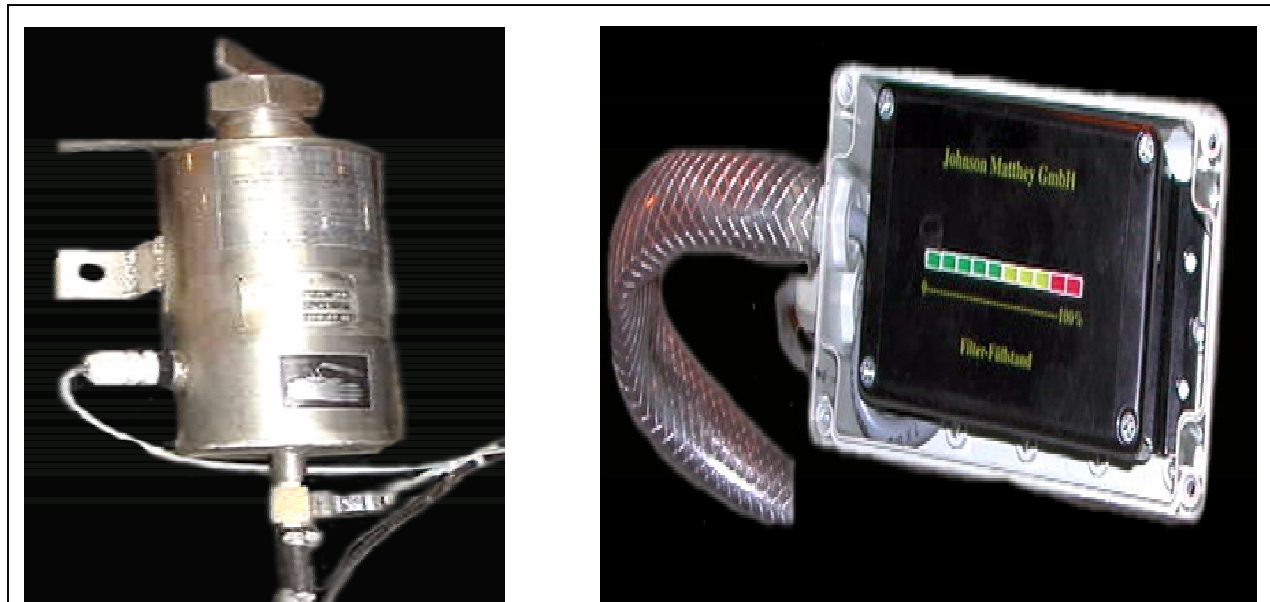
Figure 29: Automatic fuel additive equipment (left) and backpressure monitoring display on dash (right).

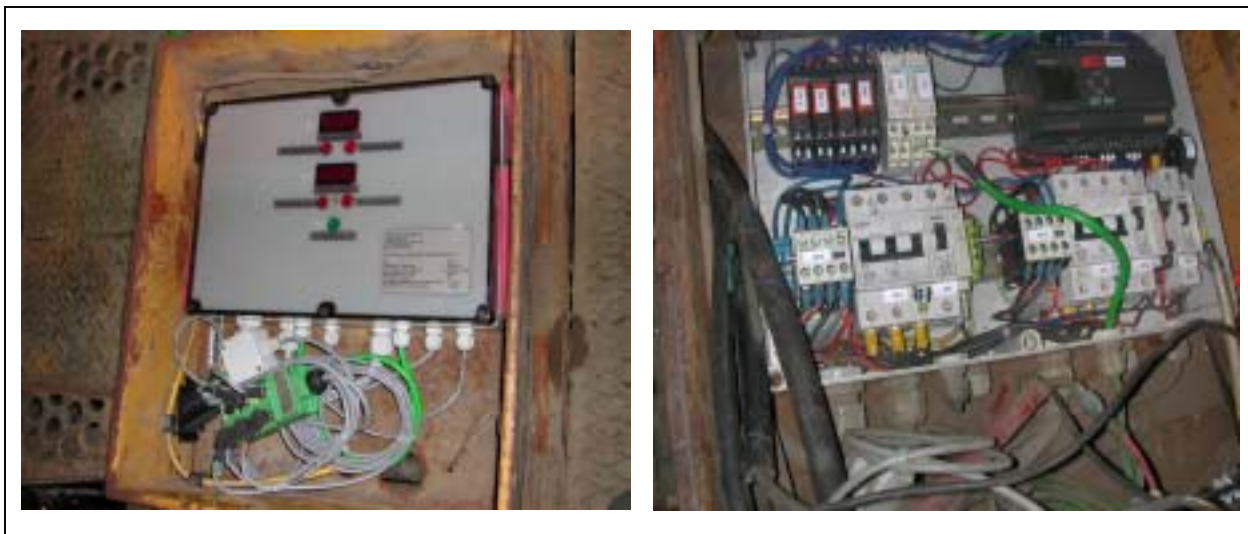
Figure 30: Display panel (on left) and inside of panel (on right) for electrical regeneration of the JM system.

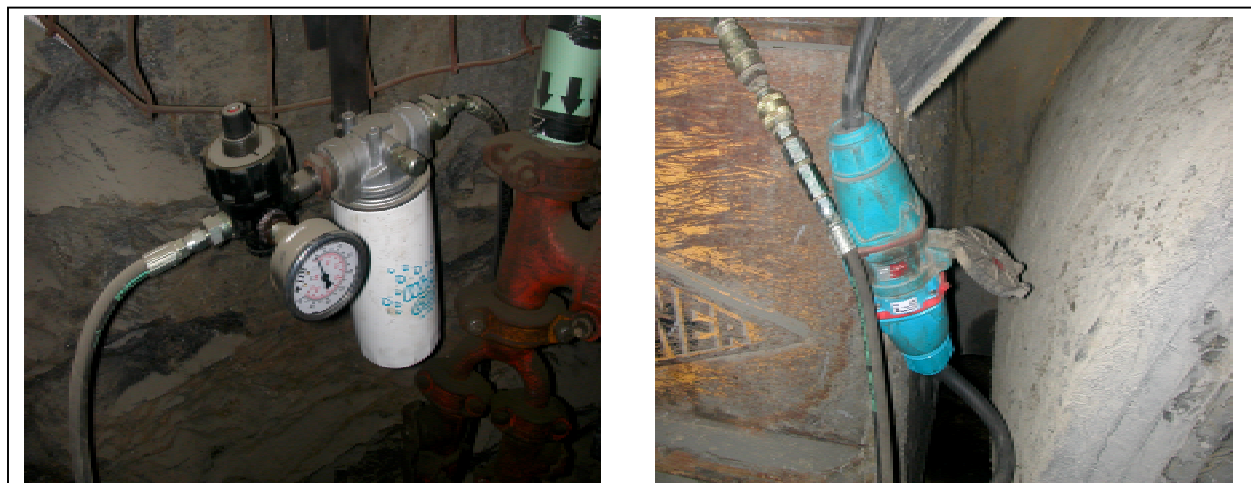
Figure 31: Air line with moisture removal and pressure gauge (left) and electrical connector (blue) and air line beside it on the right.

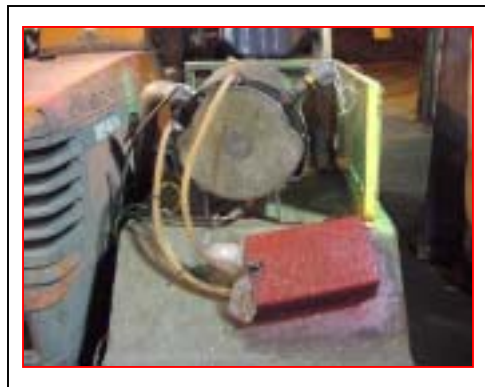
Figure 32: ECS/3M filter mounted on #2180 tractor. The yellow cage is to prevent operator contact with hot surfaces. The red box on the fender is a protective casing containing the power connector for electrical regeneration.

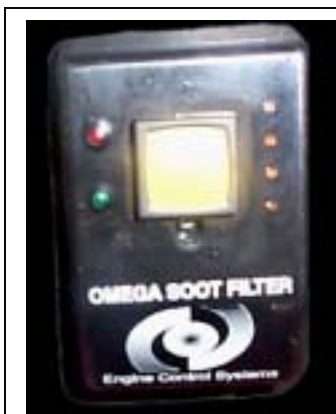
The system had its own monitoring of soot buildup based on backpressure measurements and this was displayed via two units mounted on the dash in front of the operator. As shown in Figure 33, one of these units displayed an LED progression of four steps of increasing backpressure. The other unit had a single LED (red) and an audible alarm for signaling system failure or plugging.

Figure 33: Omega dash display

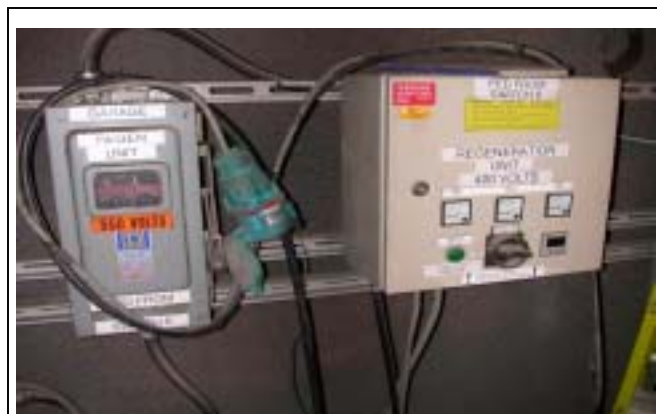
The regeneration station for the system was inside the 1800 Level garage shown in Figure 34. This station controlled the timed air flow and power to the heating element. The regeneration was to be conducted after each shift and was to last 60 minutes.

Figure 34: ECS/3M Omega regeneration station.

The unit, shown in Figure 35, was mounted horizontally on the front fender of the tractor. The main component of this system was an extruded SiC honeycomb filter. An auxiliary component was an electrical heating coil built into the intake end of the filter's housing. The filter was sized to collect soot during an 8-hour shift, immediately after which it was to be regenerated by connecting the unit to a regeneration station inside the 1800 Level garage (see earlier Figure 34). The regeneration period under these conditions was about 60 minutes.

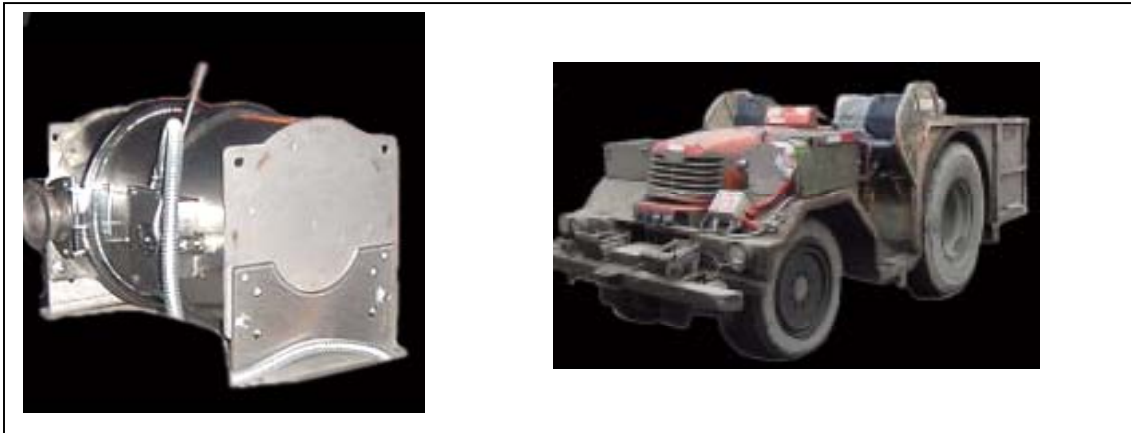
Figure 35: ECS Combifilter, left: as received; right: mounted on vehicle #2180.

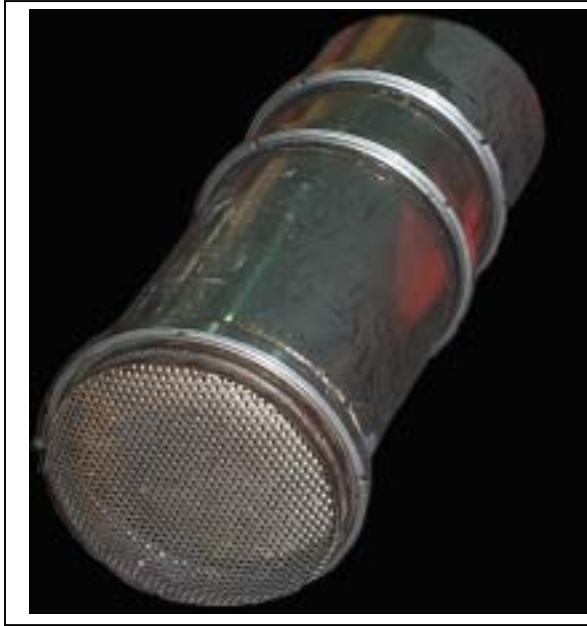
The Engelhard DPX2 filter, shown in Figure 36, was installed on LHD #362 on June 10/01. This system was fully passive utilizing an extruded cordierite honeycomb filter medium, the internal surfaces of which were coated with a platinum-based catalyst.

Figure 36: Engelhard filter

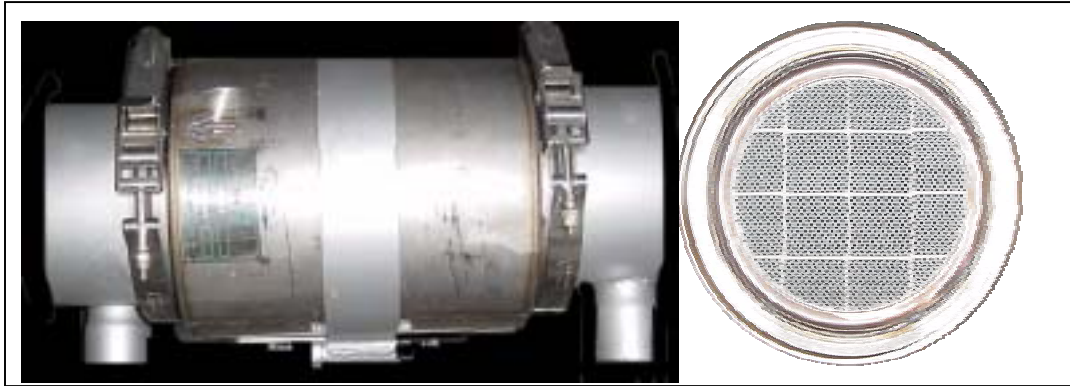
Figure 38: DCL Titan filter, side view on the left and end view on the right. The side view shows the two end caps connected to the main canister by quick disconnect clamps.

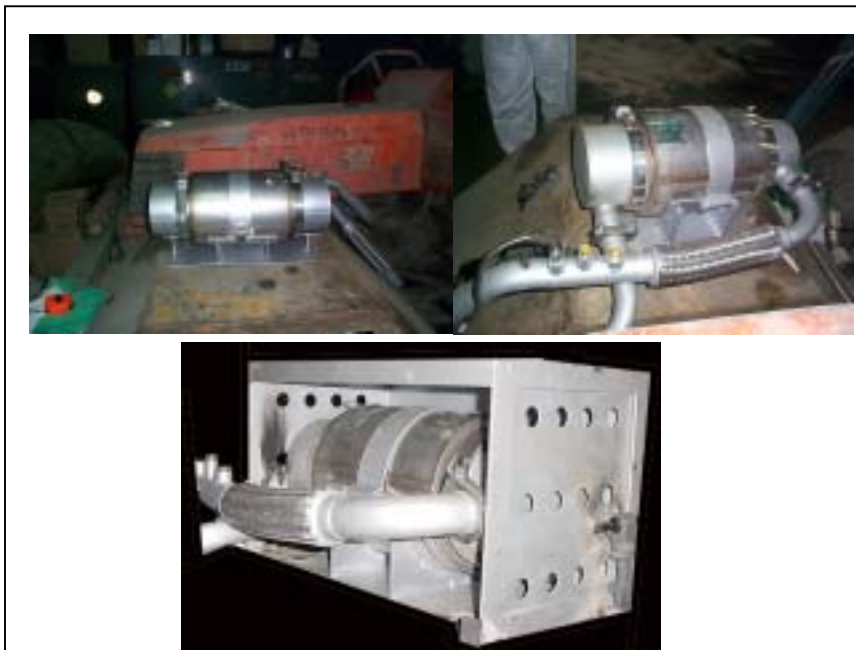
were used for easy regeneration. The filter assembly was mounted in a horizontal position on the front fender (as shown in Figure 39) and covered with a metal box to prevent operators coming into contact with its hot surfaces.

Figure 39: Views of DCL Titan mounted on the Kubota fender. Lower photograph shows the protective box.

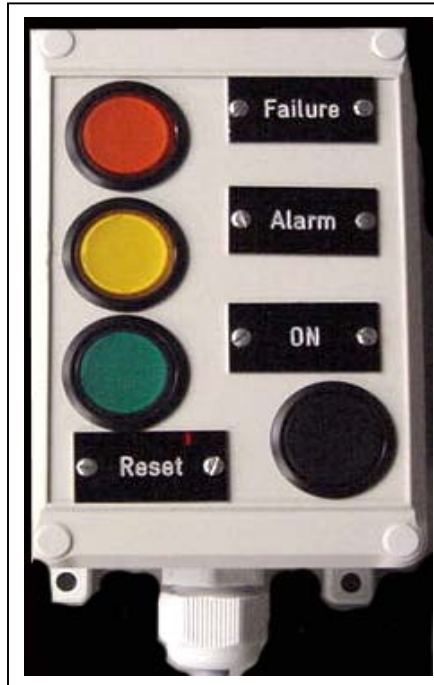
Figure 40: DCL backpressure monitor mounted on dash.

A monitoring unit (see Figure 40) for backpressure was supplied by DCL and was mounted on the dash of the vehicle. Normal operation was indicated by a green light. A yellow light indicated a backpressure of about 125 mbar as a warning that the filter was becoming loaded. A red light indicated that the filter needed to be regenerated.

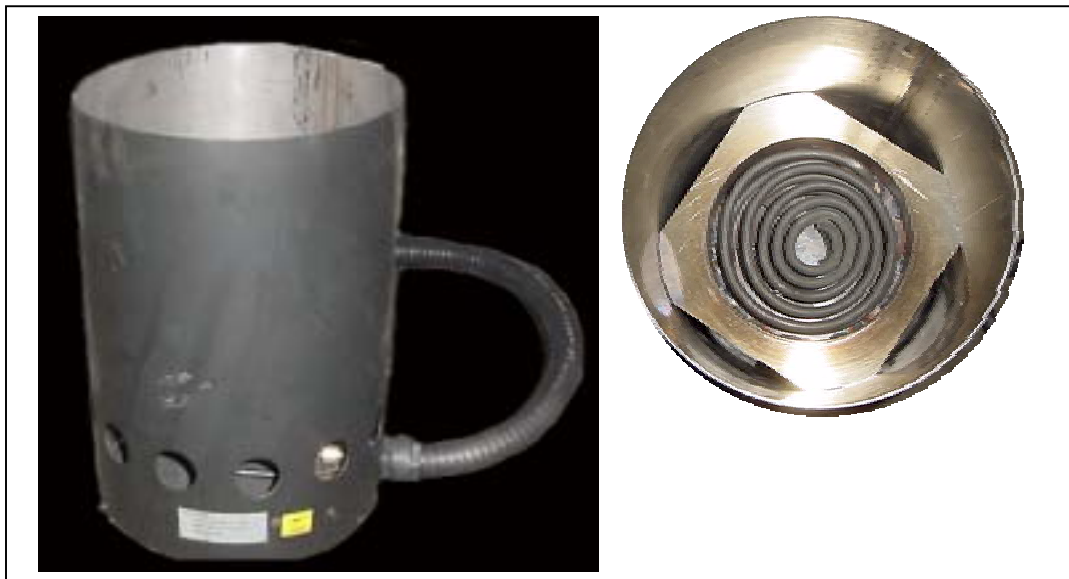
The regeneration station was located inside the 1800 Level garage. Instead of plugging an on-board system into the power station, as was done for many other DPF systems being tested at Stobie, the DCL Titan filter was removed from the vehicle and was placed in a "cooker" (shown in Figure 41) having an heating coil. The cooker was permanently connected to a wall-mounted power control panel, shown in Figure 42. The control panel activated a timed regeneration cycle which typically lasted 1-2 hours. After the heating cycle was completed, the filter was allowed to cool to room temperature before removing it from the cooker and re- installing it on the tractor.

Figure 41: Regeneration "cooker" for DCL filters: side view on left and top view (showing heater elements) on right.

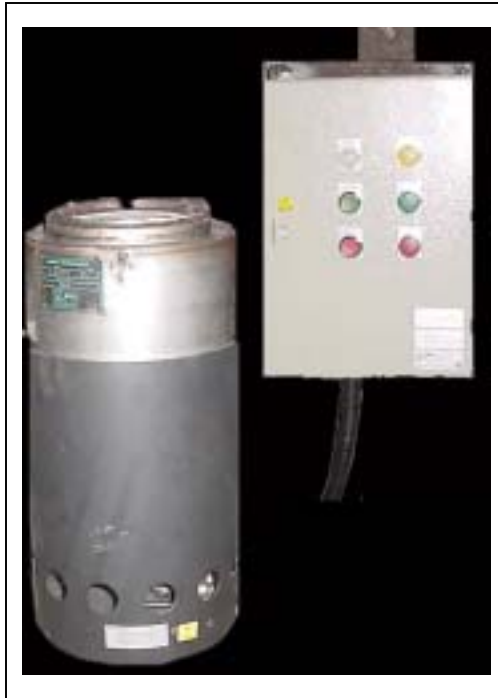
Figure 42: Regeneration station showing loaded filter in the cooker and the control panel at upper right.

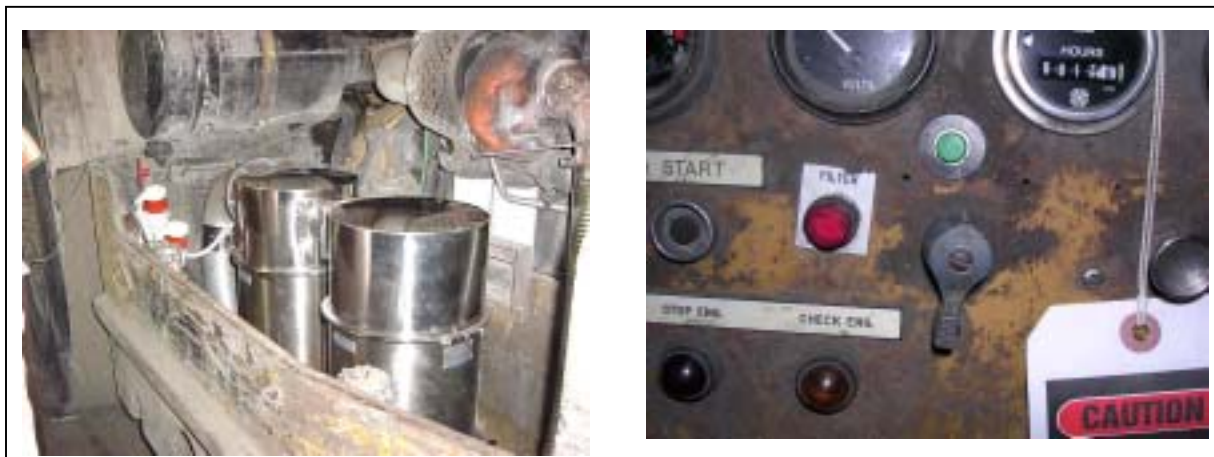
Figure 44: Side view of Combifilters (left) and backpressure monitor on dash (right).

Monitoring of backpressure was carried out by the system and a signal indicating high pressure (regeneration needed) was mounted as a red LED on the vehicle's dash shown in Figure 44 (right). A green "test" button was located next to the LED.

The filters were sized to collect soot over two working shifts with active electrical heating regeneration performed each day. The dual filters operated in parallel. Two cylinders were used instead of one cylinder due to spatial considerations (see Figure 43 and 44).

Figure 89: Damage to vehicle #213 from mucking accident. Refer to Figures 43 and 44 to see the installed positions of the dual ECS/Combifilters on this vehicle.

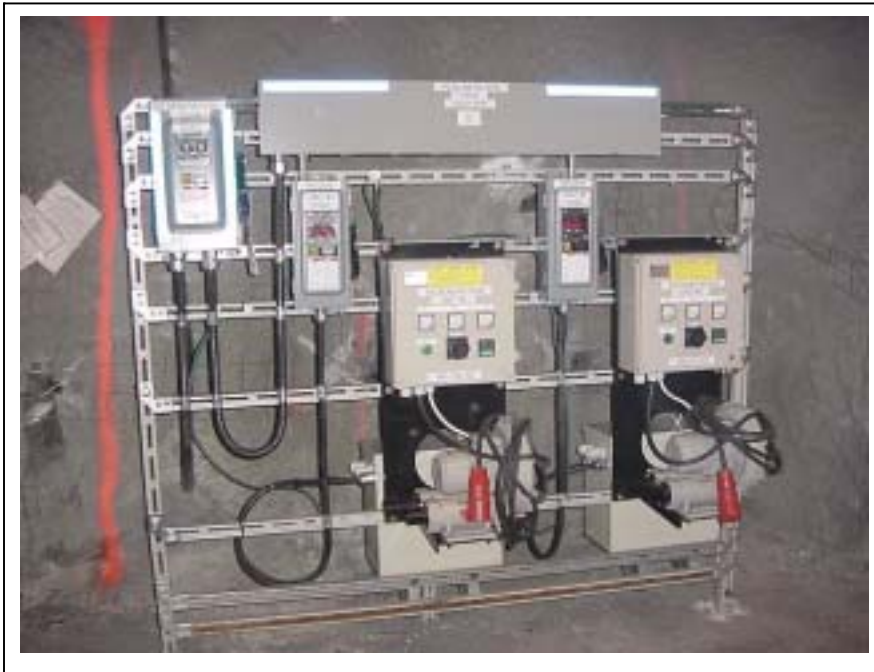
Figure 45: Regenerating station for ECS Combifilter

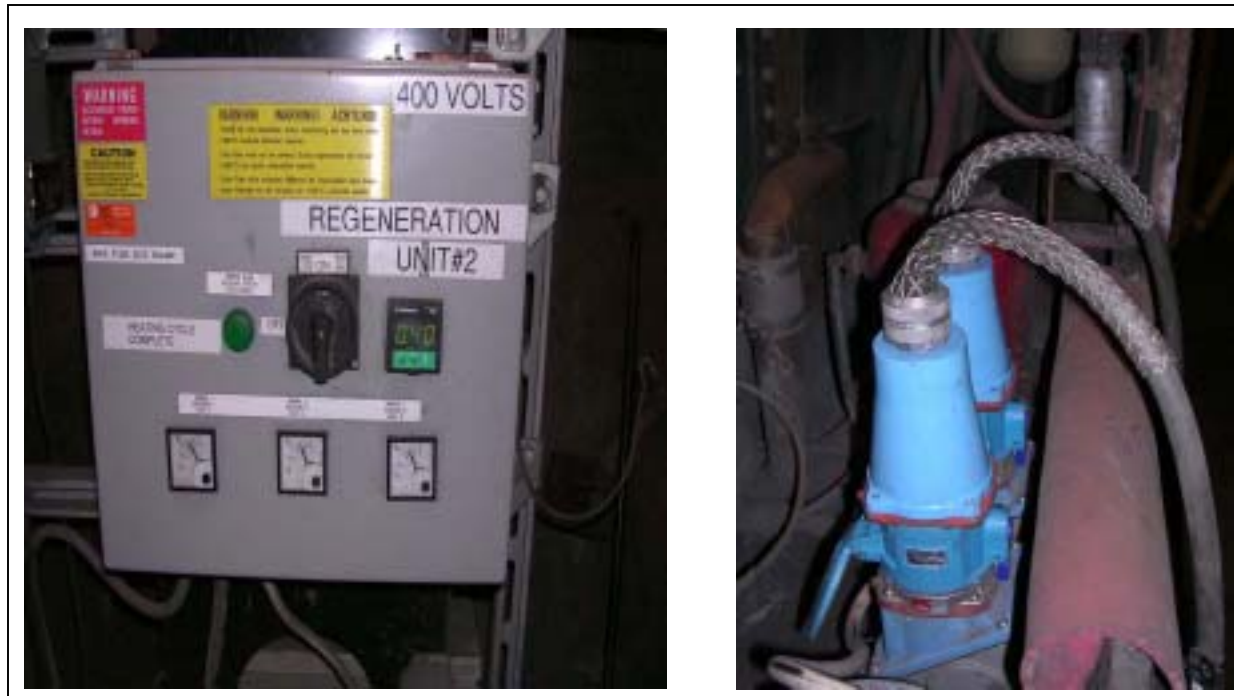
Figure 46: Regeneration control panel for one filter (left) and power cables (right).

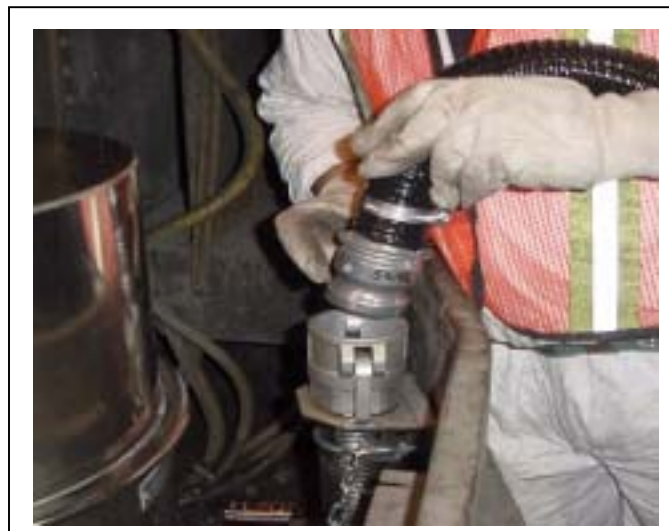
Figure 47: Compressed air connection.

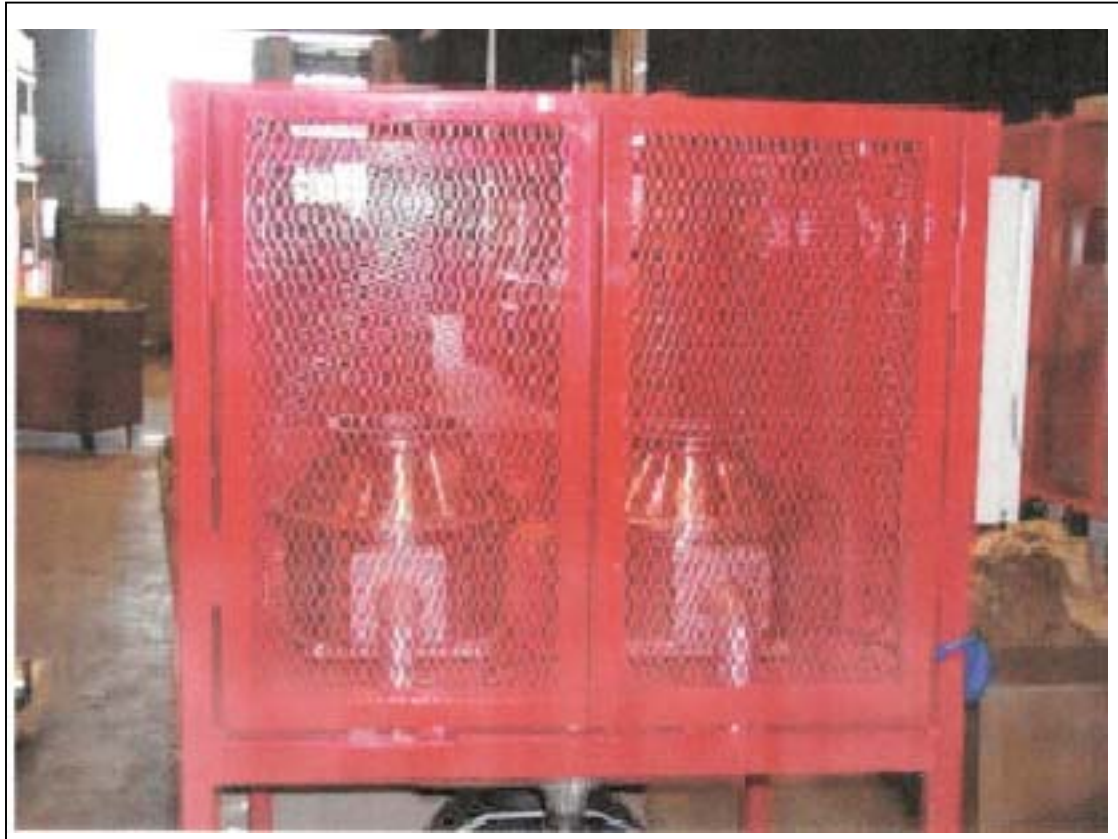
Figure 48: The ECS CombiClean™ System, consisting of dual heating compartments. Outside the picture at the bottom is a ShopVac vacuum system (see view in Figure 50) employed at certain stages in the regeneration procedure.

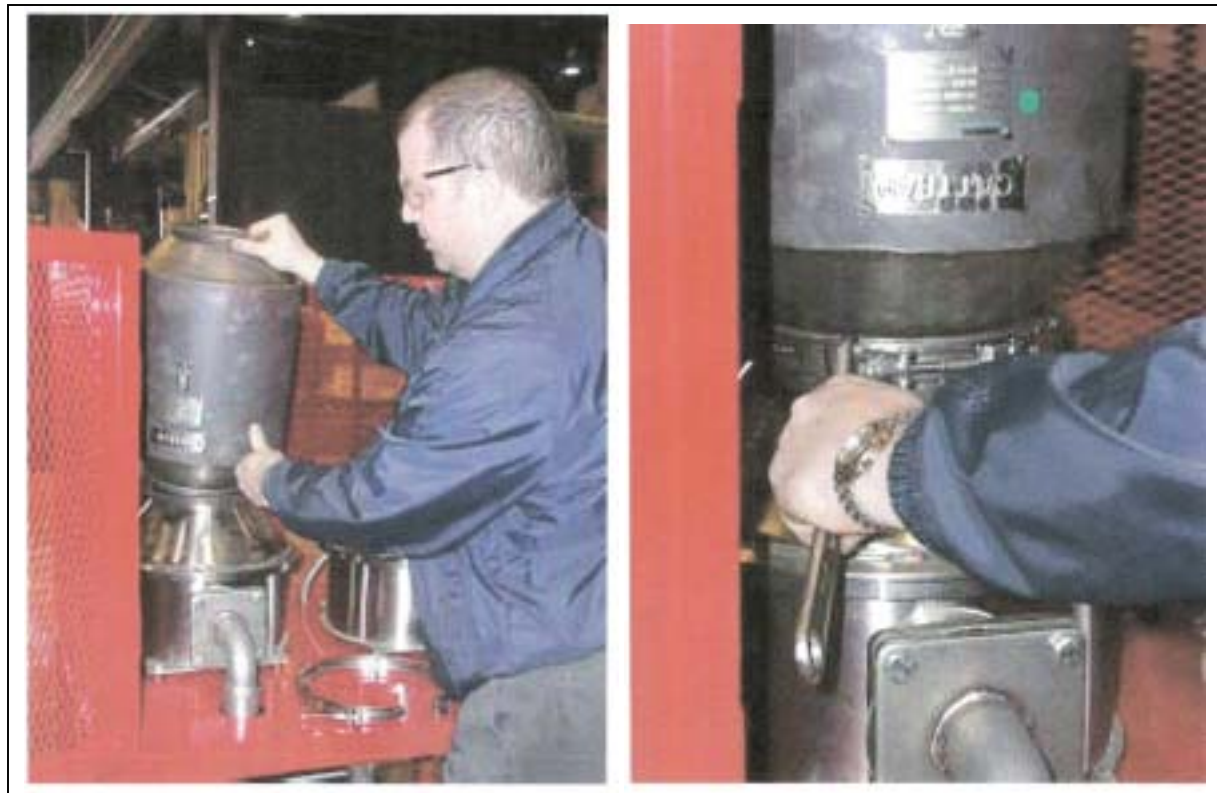
Figure 49: Placement of used filter on the heater (left) and clamping it (right).

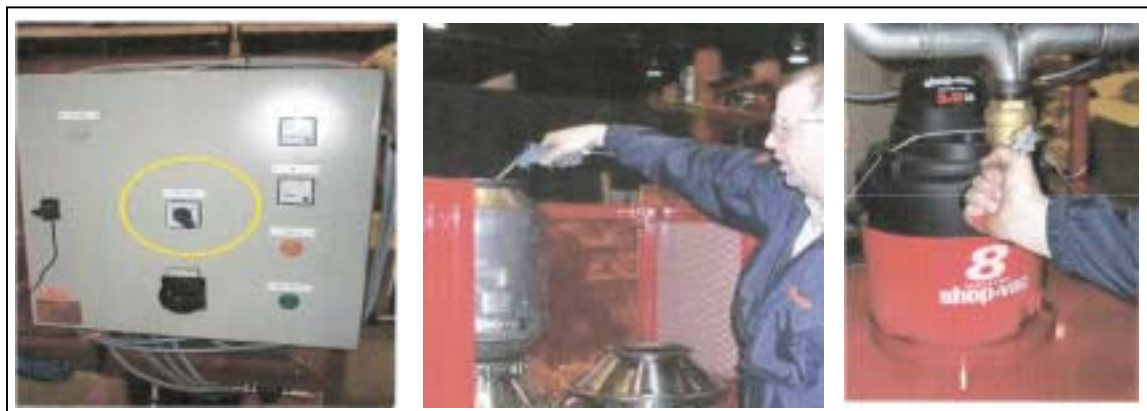
Figure 50: Control panel (left), vacuum system (right) and compressed air blowing (middle).

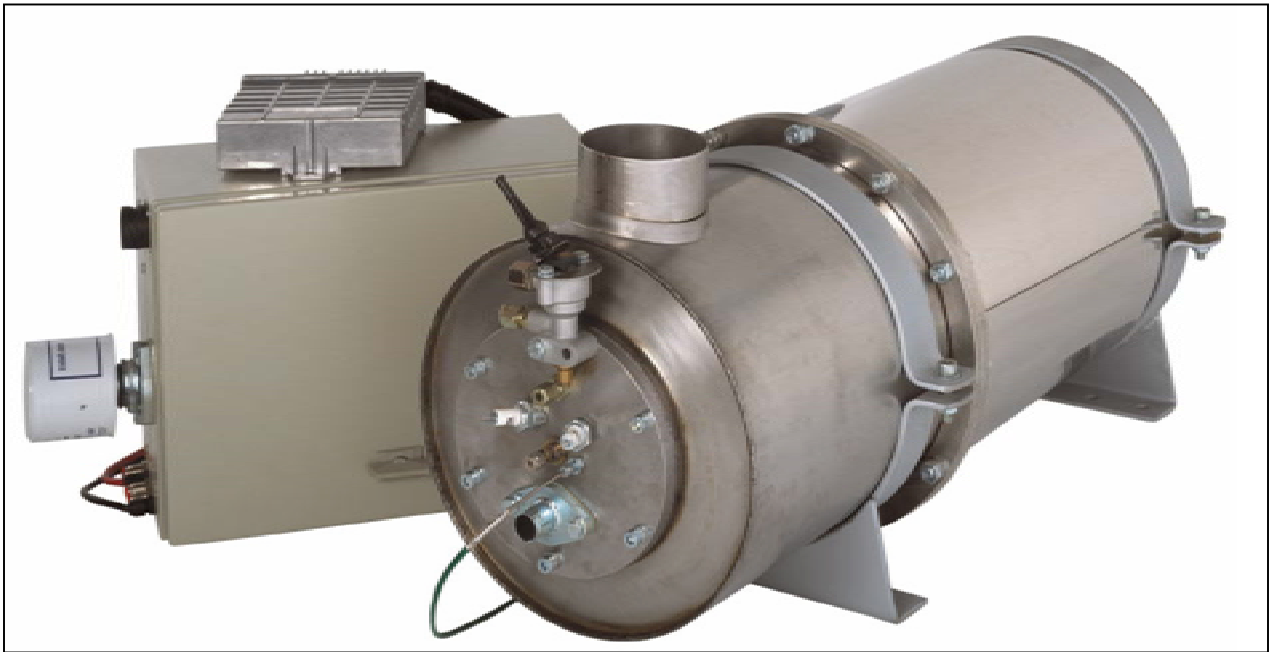
Figure 51: Arvin-Meritor PFS (horizontal position).

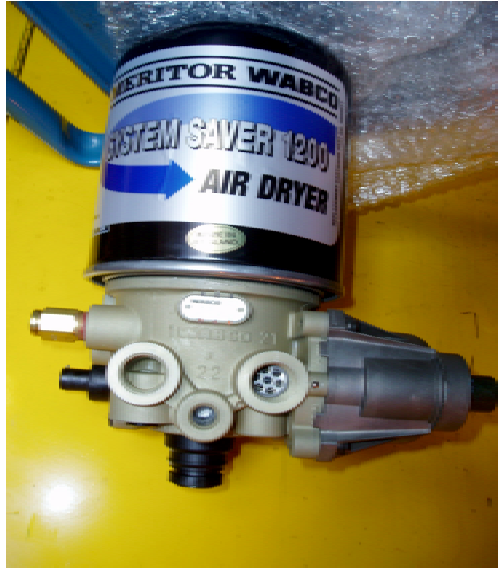
Figure 53: Air drier for burner

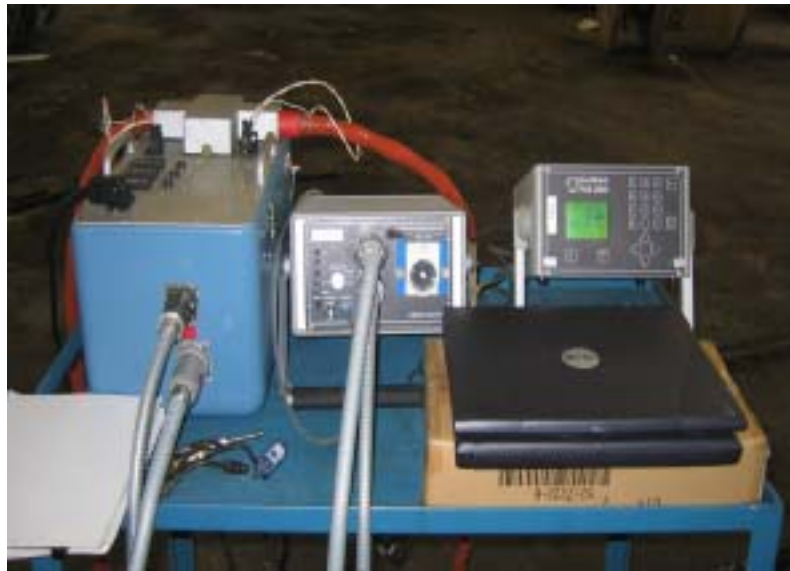
Real time high idle and torque converter stall^β concentrations were measured using a photoelectric aerosol analyzer (PAS 2000), shown in Figure 54, developed by Matter

Figure 54: PAS 2000 photoelectric aerosol analyzer (on the right) with the dilution equipment on the left.

Engineering (Wohlen, Switzerland) and marketed by EcoChem (League City, Texas). The PAS is based on the detection of ionized particles. Soot (elemental carbon) particles in diesel exhaust typically have a layer of polycyclic hydrocarbons adsorbed on their surfaces. When illuminated by ultra-violet light, these hydrocarbons become ionized and thus the soot particles become positively charged. The PAS detects the flow of these charged particles as an electric current, which is proportional to the number of particles present. Other work has shown a good correlation between the current measured and the concentration of elemental carbon. However, because particle size distributions affect the correlation between mass concentration of elemental carbon and the PAS current, and these distributions may be different upstream and downstream of a filter, the filter efficiencies so-measured are considered to be estimates of filter efficiencies.

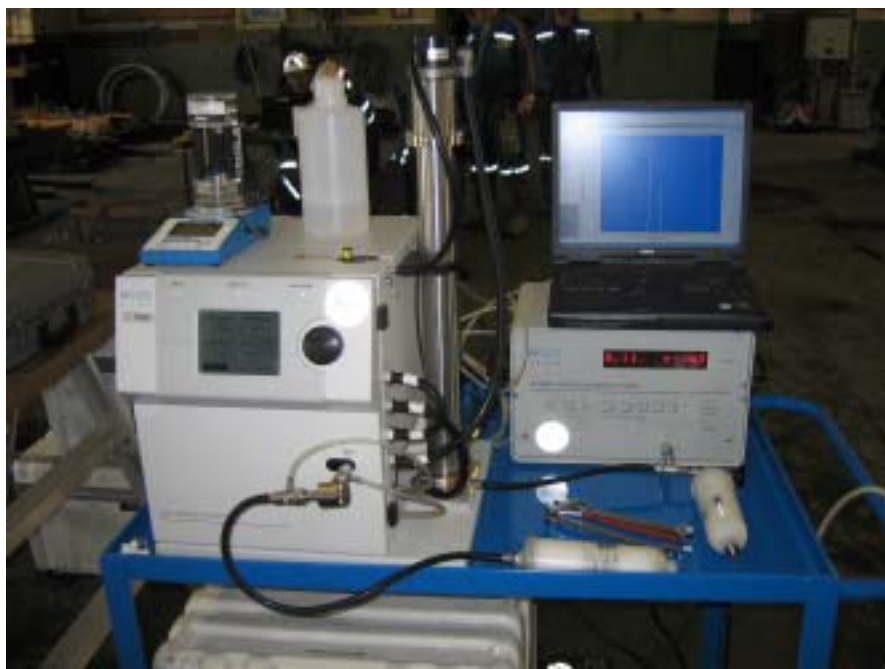
Figure 55: Scanning Mobility Particle Sizer

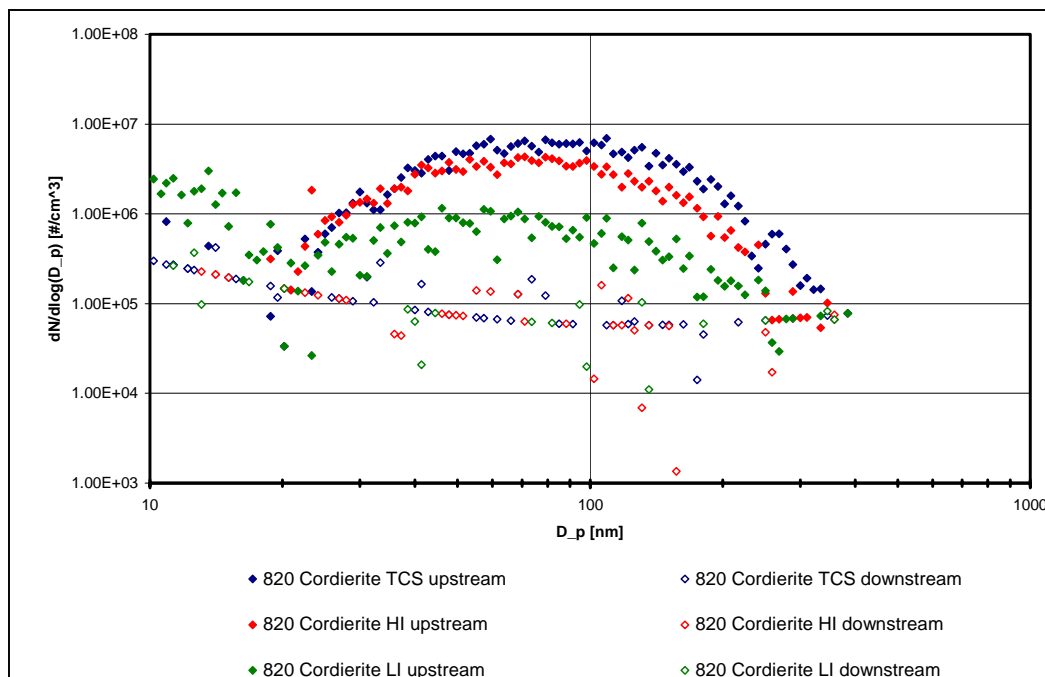
Figure 56: Example of size distributions collected over various engine conditions. Filled points are upstream of the filter and open points are downstream.
