Final Report

Evaluation of Diesel Particulate Filter Systems at Stobie Mine

March, 2006

Diesel **E**missions **E**valuation **P**rogram

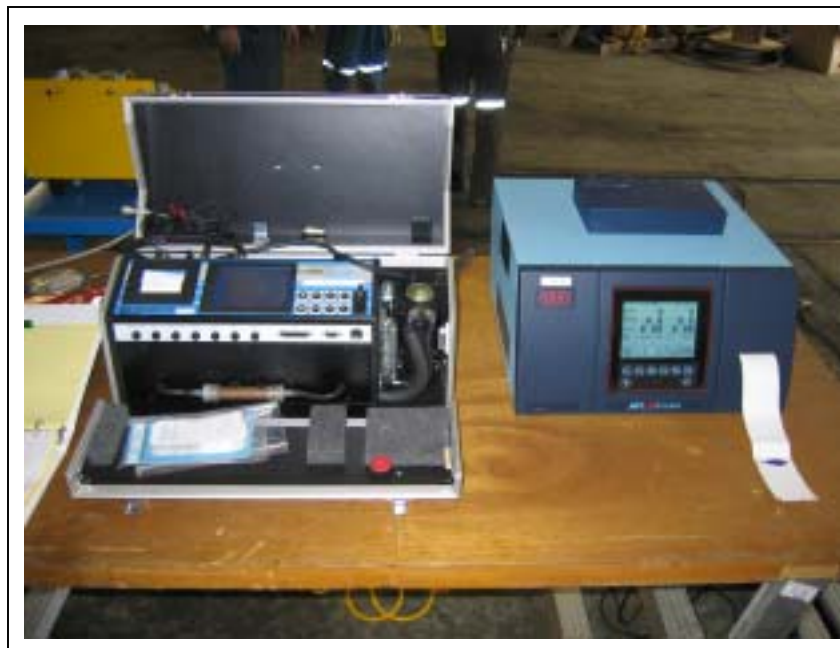
The concentrations of NO, NO₂, CO, CO₂ and O₂ were measured using ECOM KL and ECOM AC Plus portable analyzers from ECOM America (Gainsville, Georgia) shown in Figure 57.

Figure 57: ECOM gas analyzer (on the left) and the AVL Dicom 4000 (on the right)

Two ECOM units were employed for the special tests because of an interest by NIOSH in comparing the results. For the routine testing carried out by the Stobie personnel only the ECOM AC Plus unit was used and thus this report primarily focuses on measurements by that unit. Calibration of the ECOM unit was done periodically.

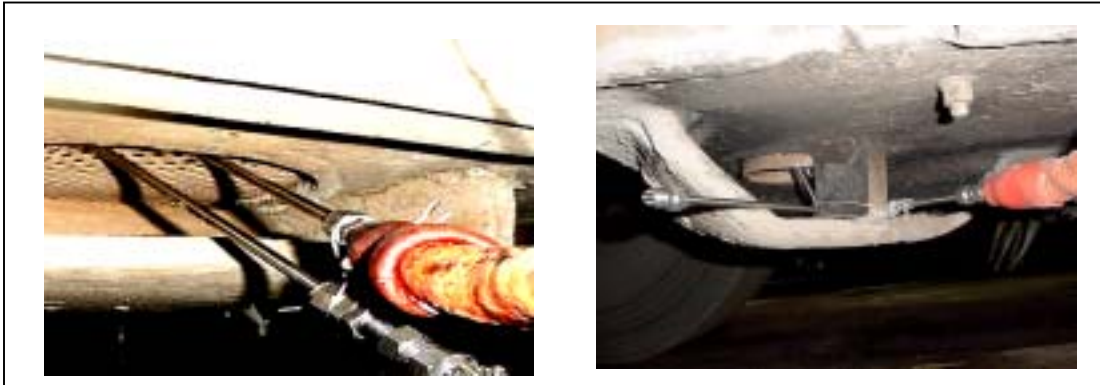
Special probes, examples of which are shown in Figure 58, were used for conducting ECOM measurements.

Figure 58: Probes for making ECOM measurements.

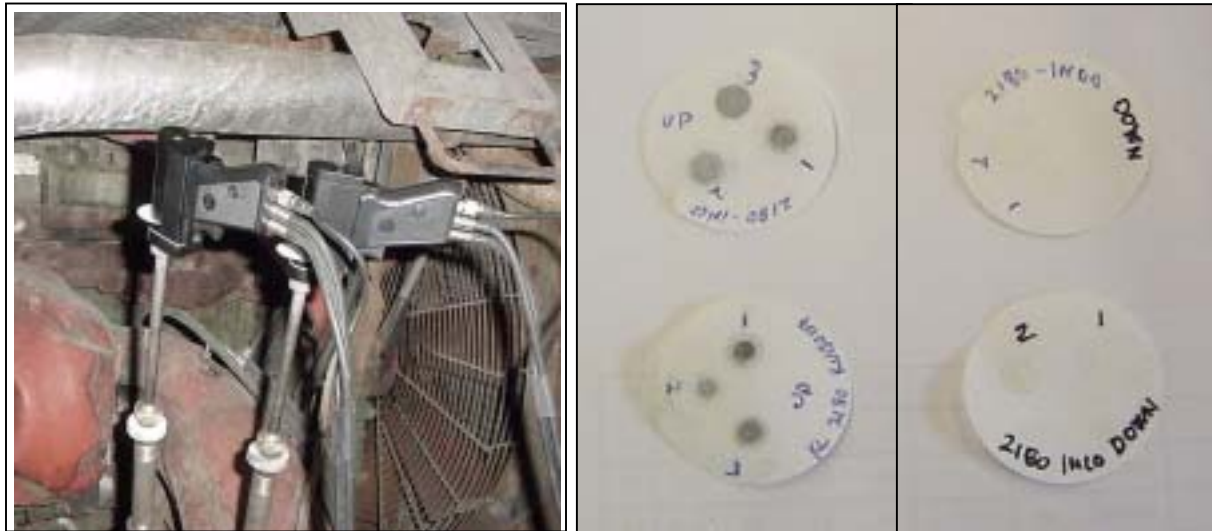
Figure 59: Probes for smoke numbers (left) and examples of filters upstream (middle) and downstream (right).

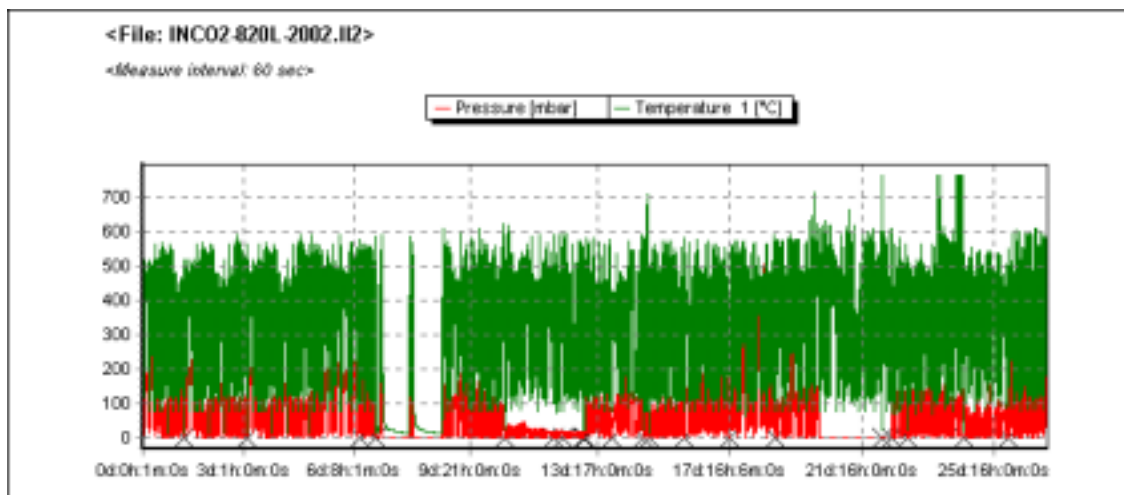
All separate periods of data belonging to one PFS were joined together to make one complete data set for that PFS. For some of the longer tests, the complete data sets were split into calendar year periods. The procedures described in Chapter 5 for editing the data from duty cycle monitoring were also employed for the PFS testing periods. An example of such a data set is shown in Figure 62 for vehicle #820 (left side). In this figure the x axis is the operating time (not real time) and the small black crosses along the x axis indicate when each sub-set of the data file was started (the start dates for each sub-file are the only times for which a calendar time exists. For the operational data, however, the calendar time is not the preferred way of displaying data because there were many periods where the vehicle and PFS were not operating. Consequently, the operating time was selected as the most appropriate way to view the data as a function of time. These graphs are contained in Appendix C for each PFS under test.

Figure 62: Example of the display of pressure and temperature data as a function of vehicle operating time.

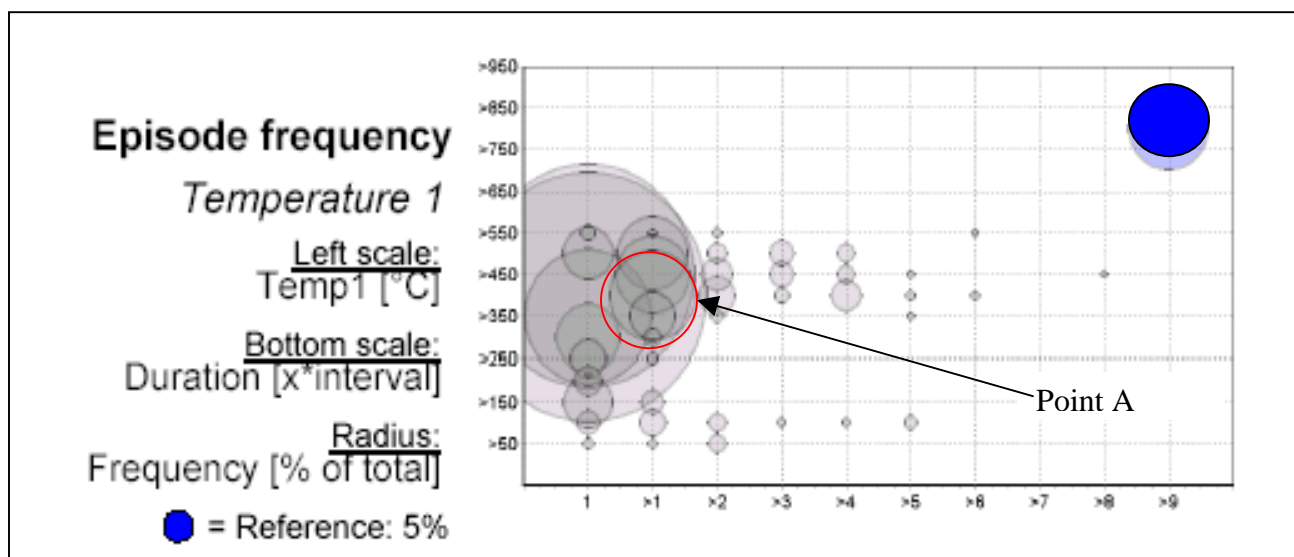
Figure 66: Example of a frequency distribution of temperature durations.

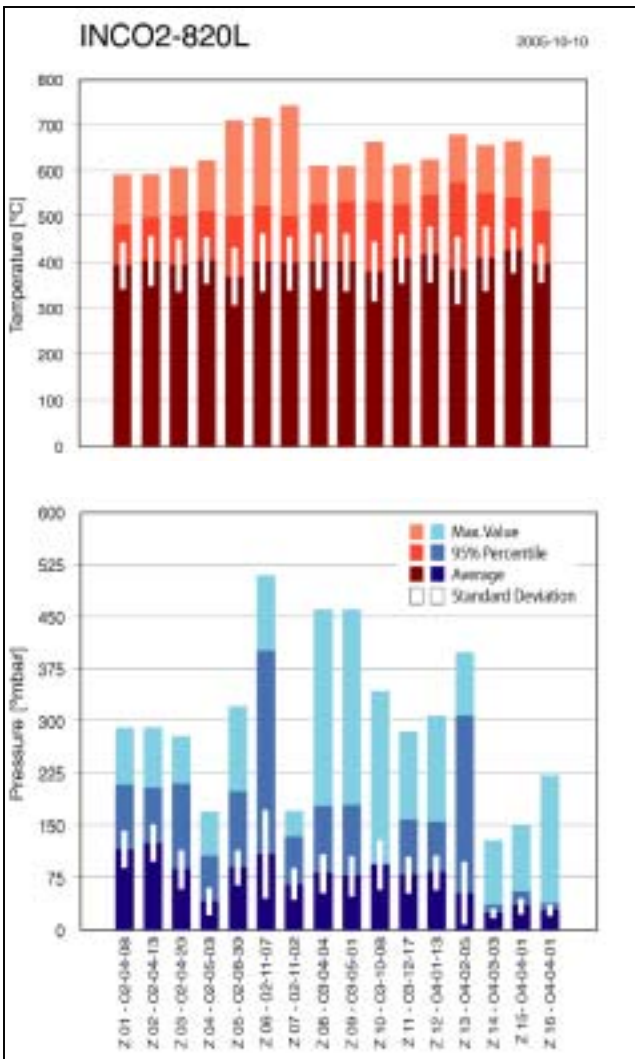
Figure 67: Example of trend plots. These plot are constructed from the statistics of the zoom data covering the entire useable data set. In this case the data from vehicle #820 (left side) is represented by 16 zoom data files covering the PFS operation from April 2002 to April 2004. Each zoom is plotted in sequence from left to right on the x-axis. The vertical white lines in each zoom represent $\pm 1\sigma$ standard deviation. The colour code is shown at the top right of the bottom diagram.

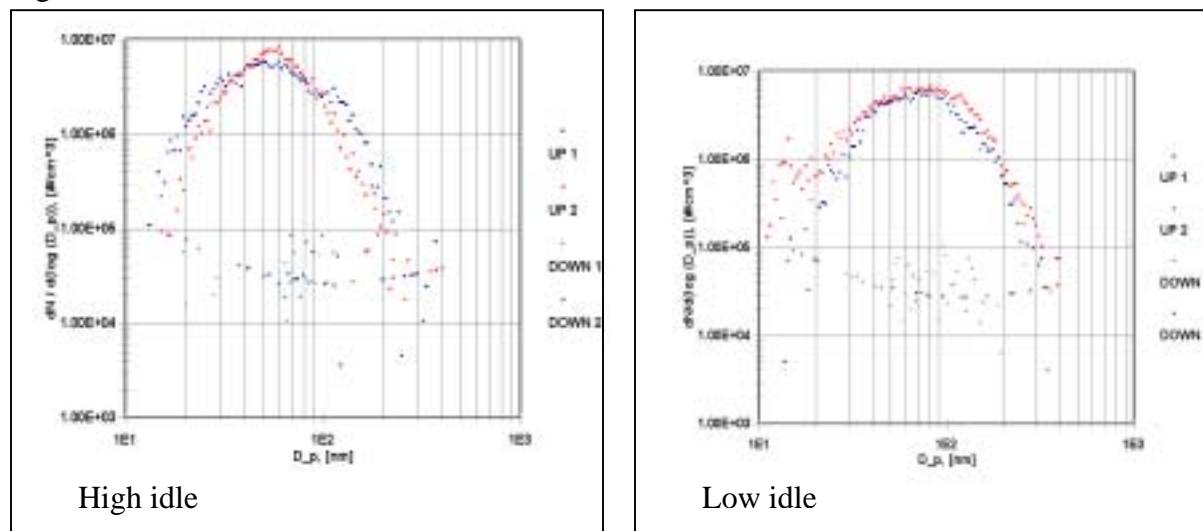
Figure 70: Size distributions of high and low idle conditions.

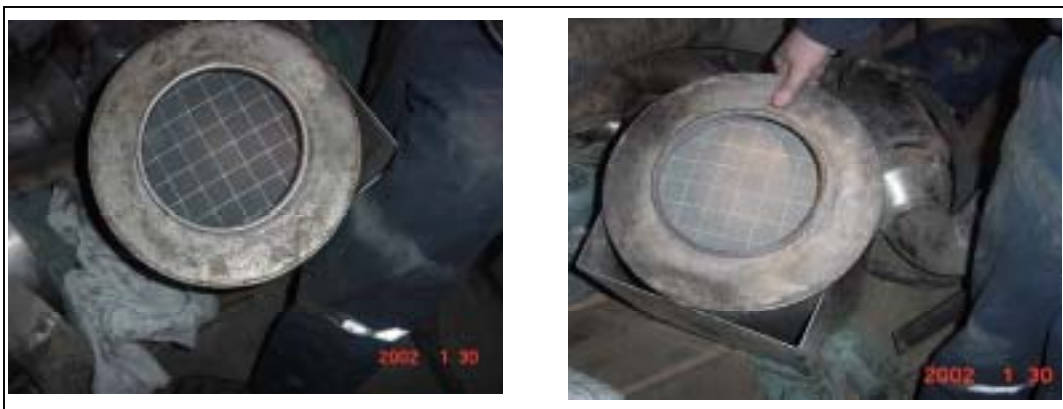
Figure 108: Johnson Matthey filter inlet side (left) and discharge side (right).

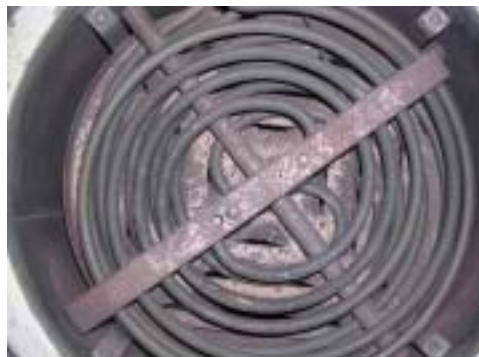
Figure 127: Inside of oven after seven “cookings” of the ECS filter.

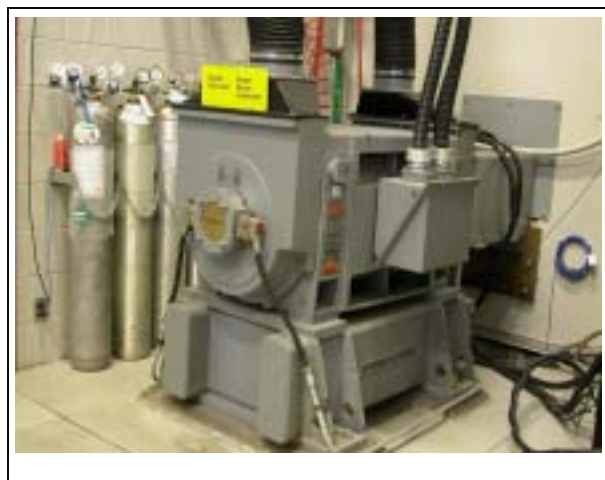
The Schenck Pegasus Corporation AC dynamometer used at CANMET, shown in Figure 132, is extremely rugged and can be controlled by a DC 6000 controller with high accuracy.

Figure 131: Dynamometer

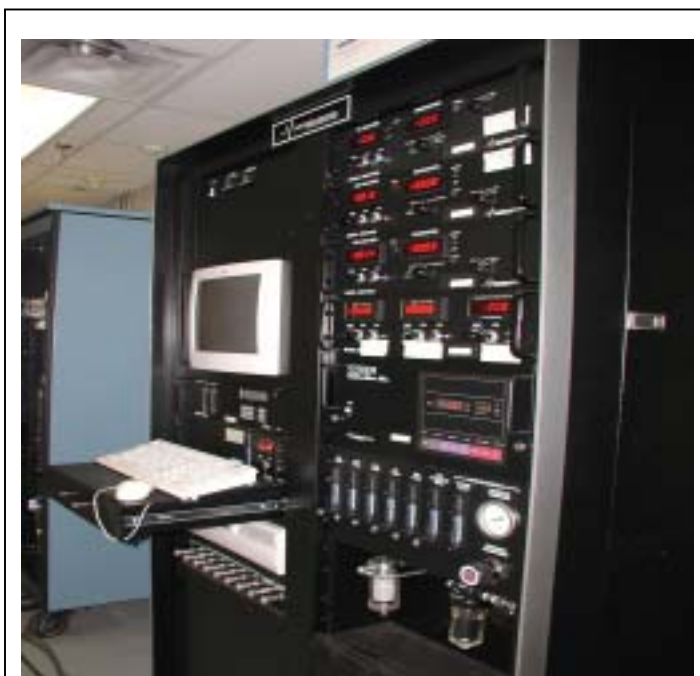
Raw diesel exhaust gas concentrations were measured by a California Analytical Instruments Company unit shown in Figure 133. This unit included a gas sampling and conditioning system, emission analysers, a 64 point gas divider for calibration, and an NO_x efficiency tester.

Figure 133: Raw gas analysis unit.

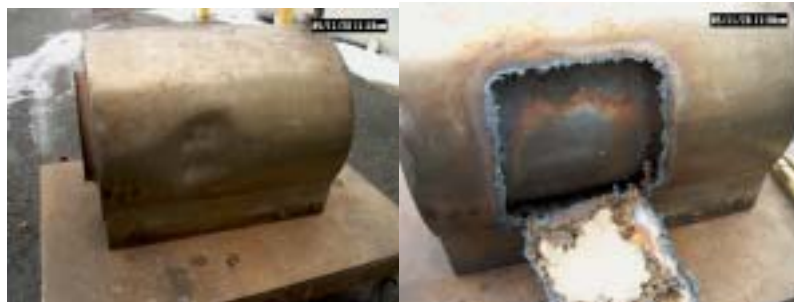
Figure 134: Johnson Matthey outer shell dent (right) and undamaged inner canister (left).

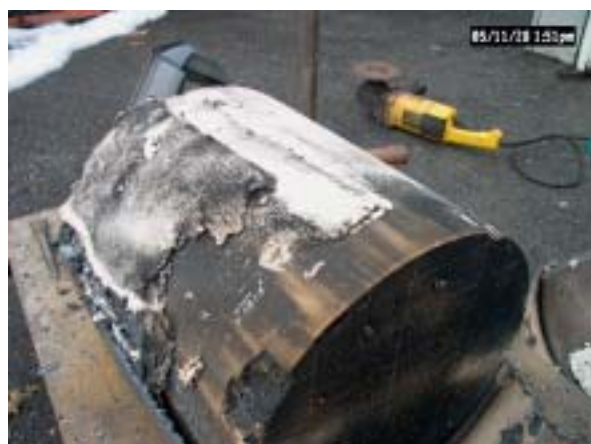
Figure 135: Degradation of mat holding JM monolith in place.
